**PHASE I ENVIRONMENTAL SITE ASSESSMENT**

Turchin Estate  
180 East Main Street  
Tilton, New Hampshire  
DES#199311019

## Phase I – Environmental Site Assessment

Turchin Estate  
180 East Main Street  
Tilton, New Hampshire  
DES Site #199311019

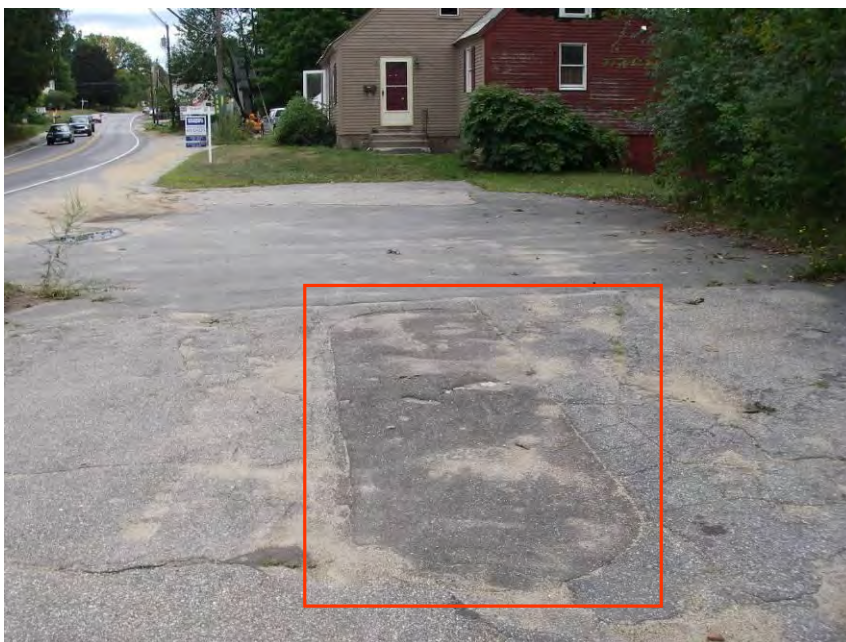
**Picture 4**  
View of pavement  
patch where former  
fueling island was  
located.

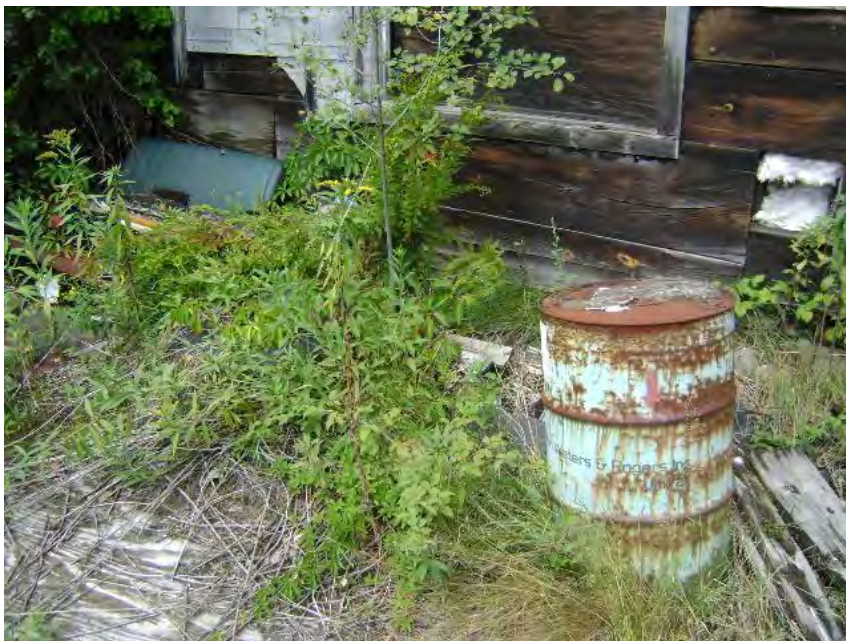
### Picture 5

One (1) 55-gallon drum with unknown contents was observed adjacent to the southern exterior wall of the garage (**Picture 5**).

View of the 55-gallon drum with unknown contents.

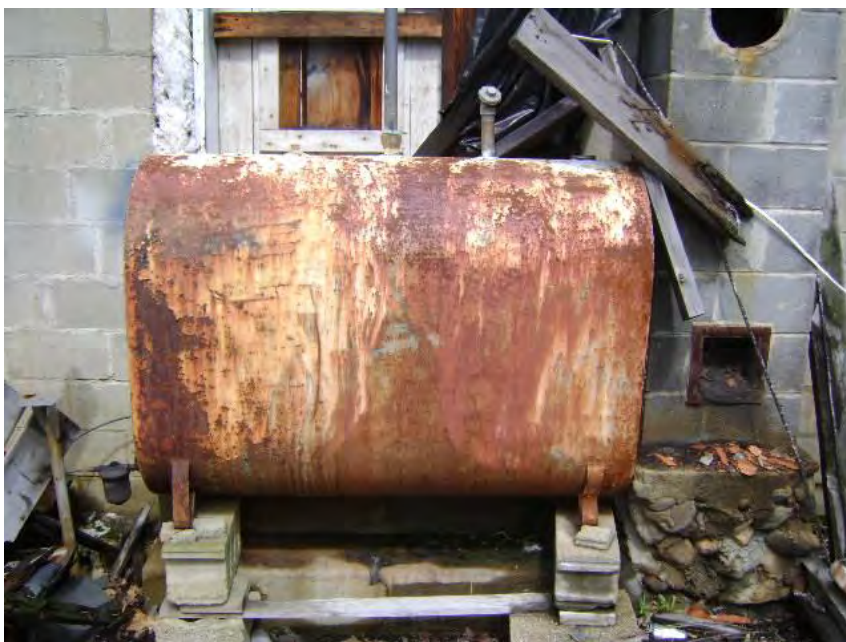
### Picture 6

One (1) 275-gallon AST was observed adjacent to the southern exterior wall of the garage (**Picture 6**). The tank was corroded on the outside. There was no surficial visual evidence of a release on the AST. It was estimated, by tapping on the outside of the tank wall, that the tank is approximately 1/3 full of liquid. The concrete base below the tank was discolored, possibly indicative of a previous release of petroleum; however, the observed potential staining may have been the result of the previous day's rain event.

View of the 275-gallon AST observed outside on the south side of the garage.

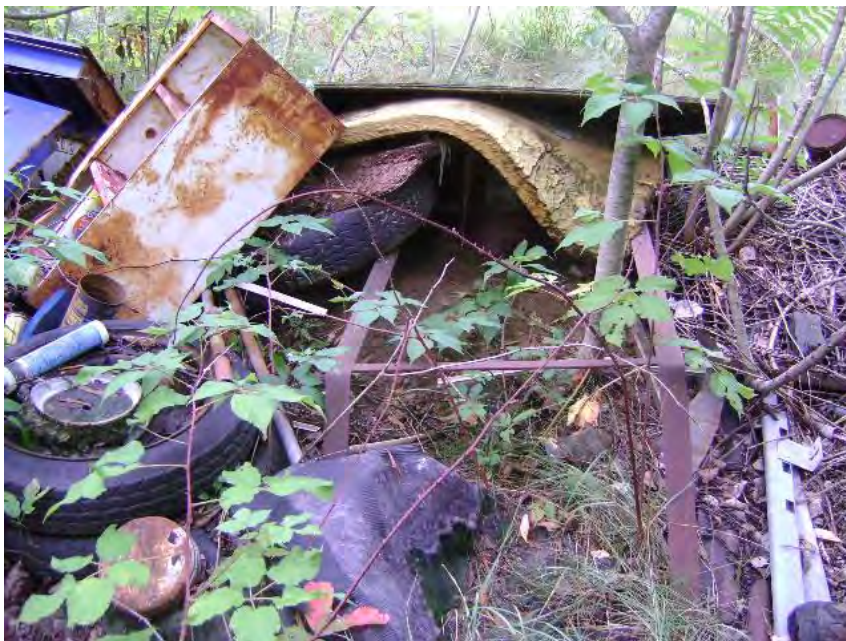
### Picture 7

Several debris piles were observed throughout the subject property. A surficial visual inspection of these piles identified scrap metal, discarded automobile parts, plastic, tires, scrap wood, and general household refuse (**Picture 7**). One (1) discarded automobile gas tank was observed in the debris pile located outside of the southwestern corner of the garage (**Picture 8**). One (1) discarded pickup truck bed (**Picture 9**) and one (1) pile of approximately 15 wooden utility pole sections (**Picture 10**) were observed in the wooded southeastern portion of the subject property.

Representative view of a debris pile located on the east side of the subject property.

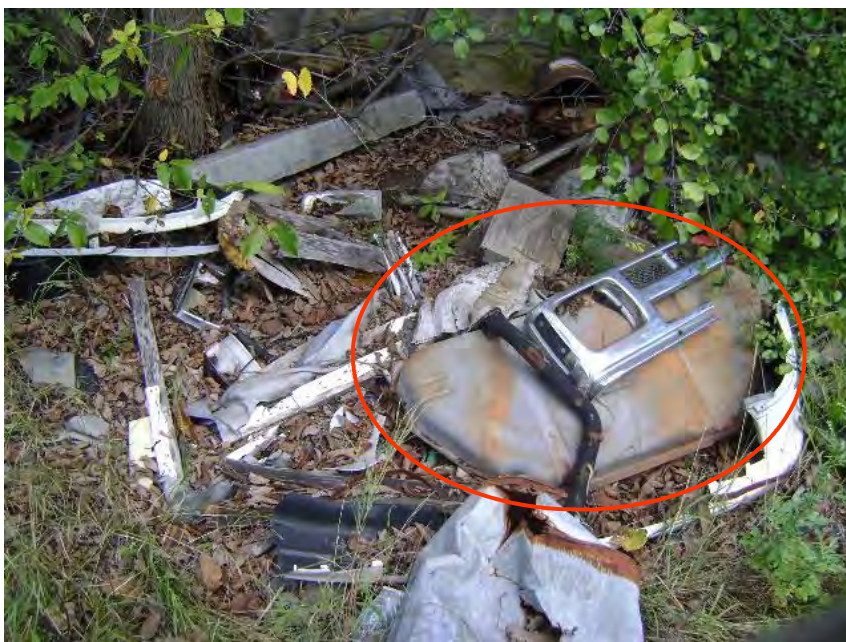
### Picture 8

View of the discarded automobile gasoline tank observed in a debris pile on the subject property.

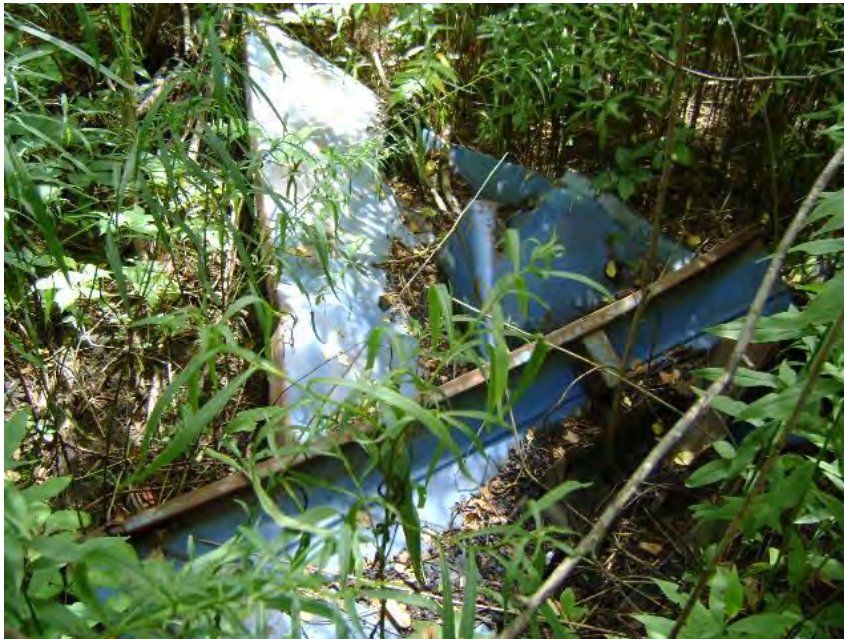
### Picture 9

View of the discarded pickup truck bed observed in the southeast corner of the subject property.

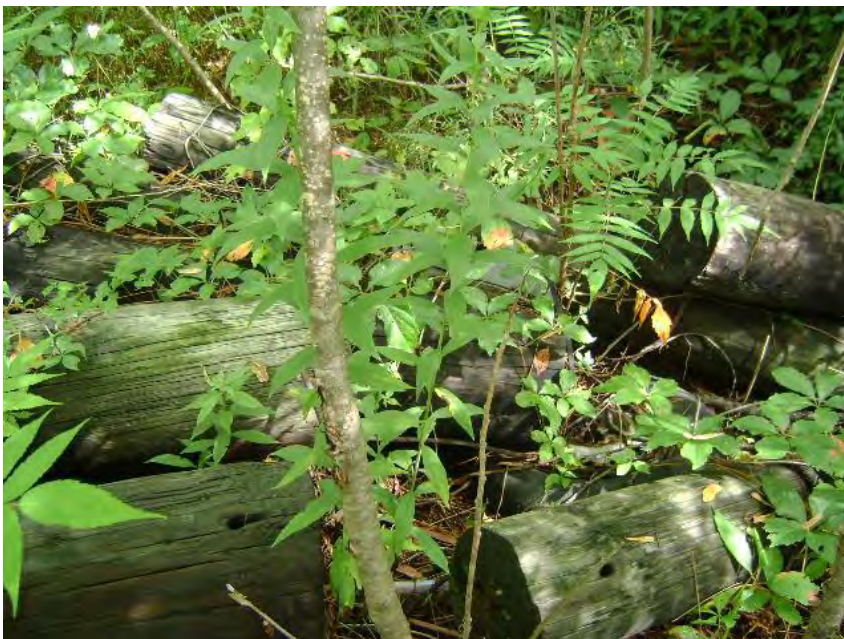
### Picture 10

- REC-5 – A suspected dump and fill area was observed along the southern portion of the subject property including items such as, but not limited to, urban fill, automobile parts, and utility pole sections. Petroleum products and/or hazardous substances associated with these materials may have been released and impacted the environmental conditions at the subject property.

Representative view of the pile of wooden utility poles observed in the southeast corner of the subject property.

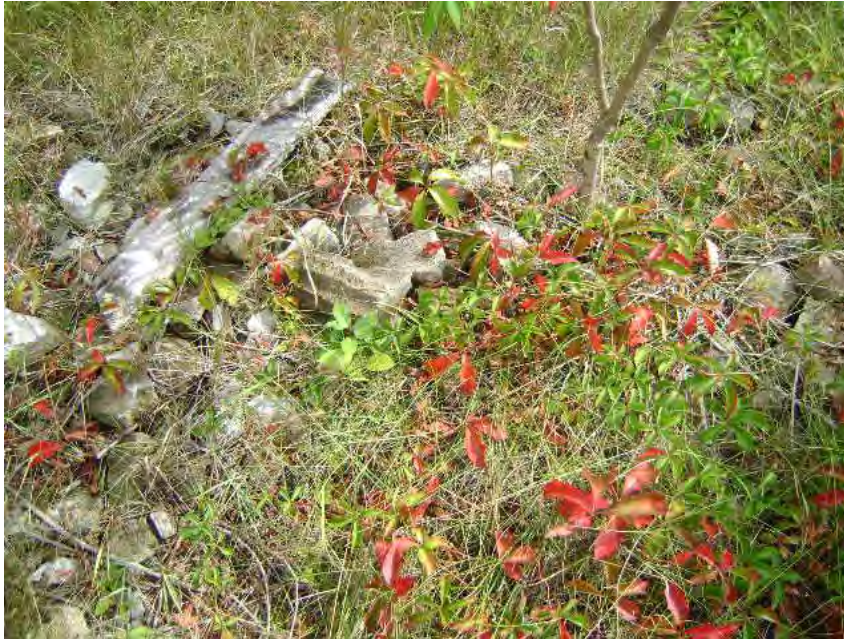
### Picture 11

The southern portion of the subject property was observed from the surface to have been filled with material containing gravel, brick, cinder block, pavement, and concrete (**Picture 11**). A mound in the southeast corner of the subject property appears to consist of similar fill material and waste asphalt (**Picture 12**).

Representative view showing fill material used on the subject property.

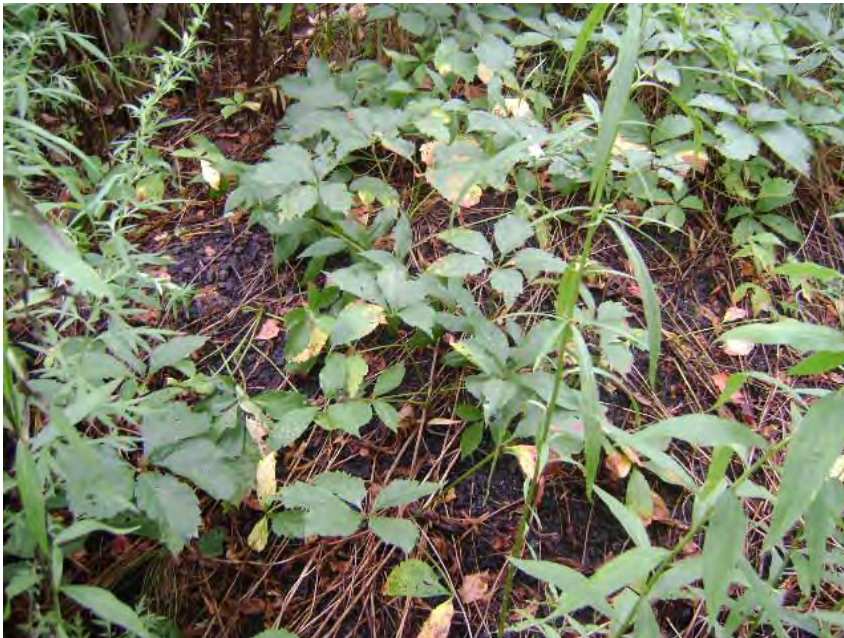
### Picture 12

Representative view of the mound of discarded asphalt located in the southeastern corner of the subject property.

(Note the black asphalt through the vegetation.)

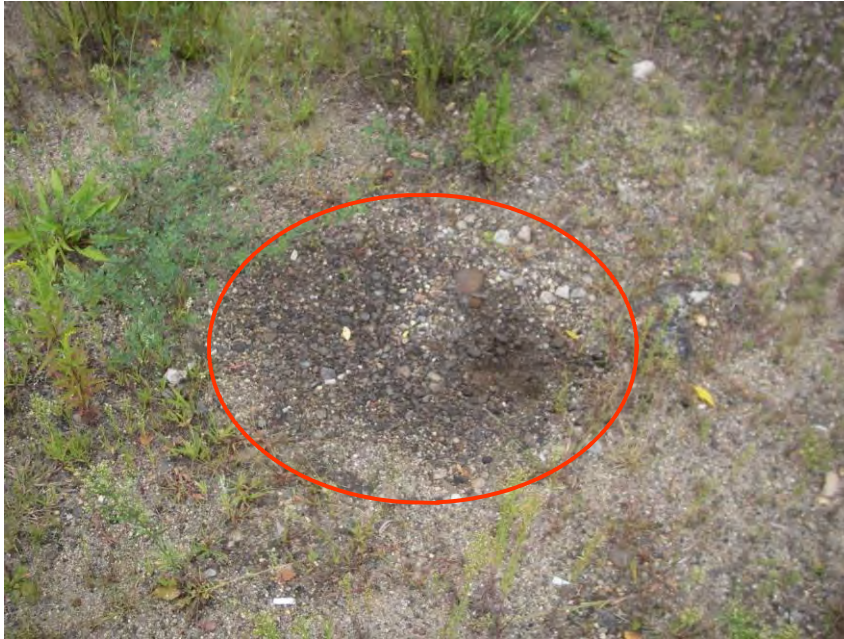
### Picture 13

- DMEC-3 – Multiple stains observed on the gravel parking lot represent a DMEC because they are evidence of small petroleum releases which may have impacted surficial soil at the subject property. However, based on observed conditions, it is not likely that these small spills have significantly impacted environmental media at the subject property.

Several small stains were observed on the gravel parking area on the west side of the subject property (**Picture 13**). Though additional investigation would be required to define the extent of the identified stained areas, based on observed conditions it is likely that these stains are

associated with oil and gas dripping from automobiles that were parked on the subject property and not the result of a sudden release of oil and/or hazardous materials.

Representative view showing one of the multiple stained gravel areas on the subject property.

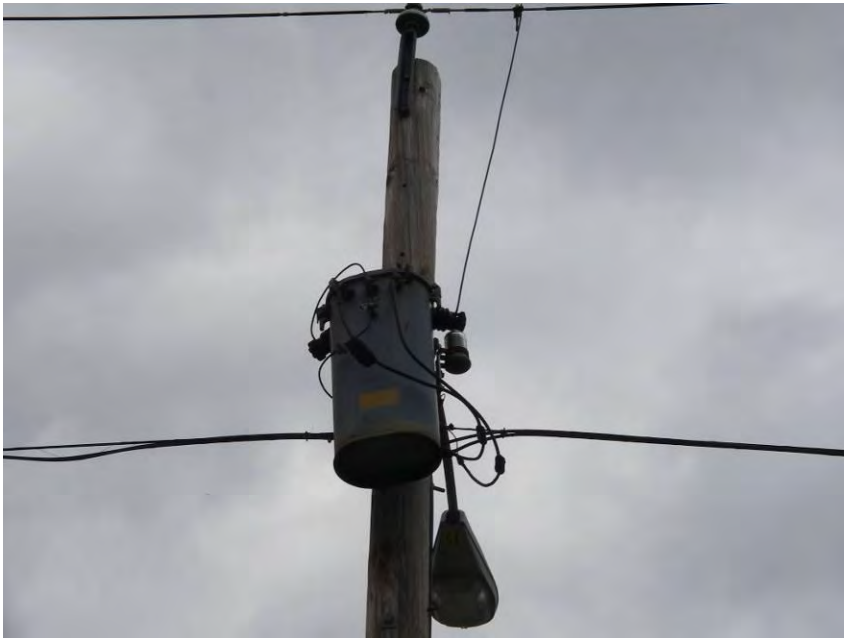
### Picture 14

- REC-6 – Stressed vegetation was observed below a pole mounted electrical transformer located along the northern subject property boundary. This condition represents a REC because it could be indicative of a release of petroleum-based and/or polychlorinated biphenyl (PCB)-containing dielectric fluid that may have impacted the environmental conditions of the subject property.

One (1) electrical transformer was observed mounted on the utility pole located in the northwest portion of the subject property (**Picture 14**). Stressed vegetation was observed below the transformer. No labeling indicating the polychlorinated biphenyl (PCB) concentration, if any, of dielectric fluid contained within this transformer was observed.

View of the pole mounted electrical transformer observed on the subject property.

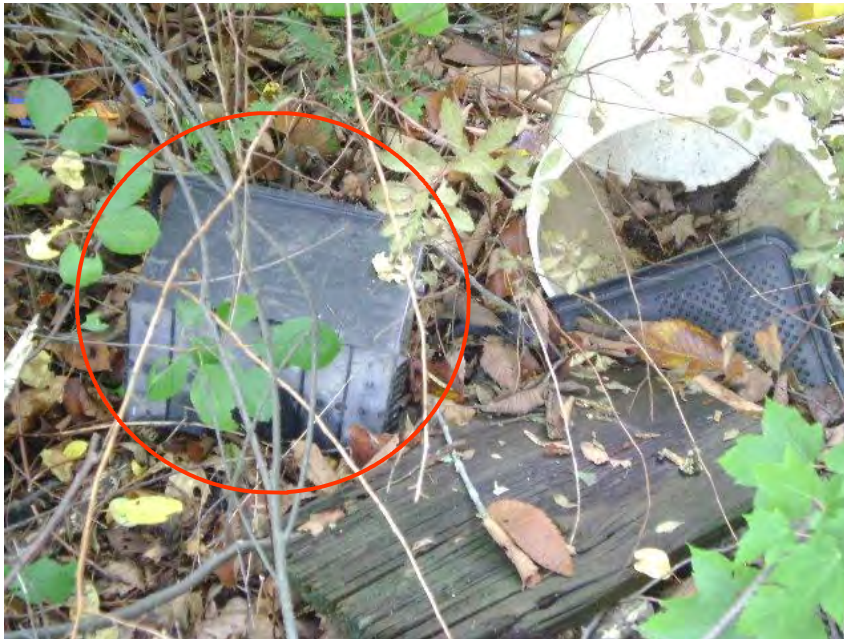
**Picture 15**

One (1) discarded car battery was observed on the ground on the north side of the cottage (**Picture 15**).

View of the discarded car battery observed in a debris pile on the north side of the subject property.

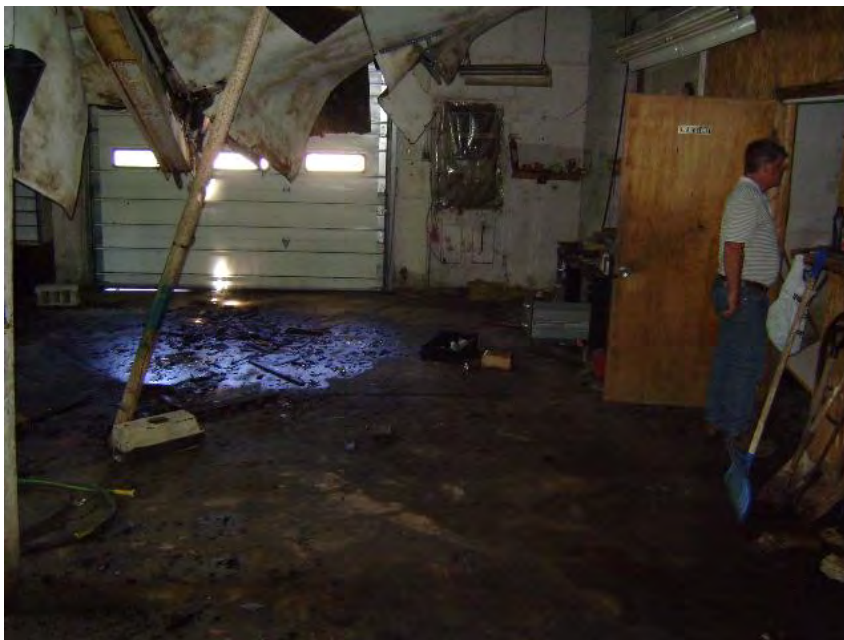
**Picture 16**

The garage bay consists of a concrete slab floor, painted and unpainted wooden panel and concrete block walls, and a sheetrock ceiling. The ceiling in the garage bay has collapsed (**Picture 16**). A floor drain was observed in the garage bay (**Picture 17**). Though additional investigation is needed to determine the outfall of this floor drain, it is likely that it is connected to the municipal sewer system. Water leaking onto the floor from the collapsed roof prevented identification of staining around the floor drain. However, staining was observed on the floor in other areas of the garage bay (**Picture 18**). Multiple small volume automotive fluid containers were also observed in the garage bay (**Pictures 19 and 20**). No evidence of the use of hydraulic equipment was identified during the site visit. However, tax records indicate that a hydraulic lift was present in the garage in 1978 (see **Sections 6.1 and 12**).

Representative view of the garage bay and collapsed roof and ceiling.

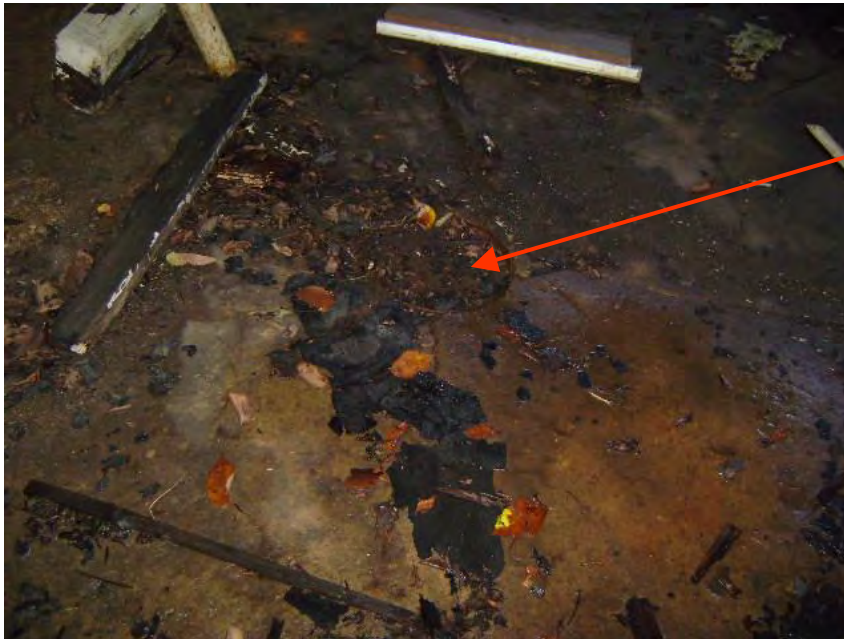
- REC-4 – At least one floor drain was observed within the garage bay with an unknown discharge point. This condition represents a REC because the drain is a potential conduit to the environment whereby releases of petroleum products and hazardous substances from former activities may have impacted the environmental conditions at the subject property.

**Picture 17**  
View of the floor  
drain in the garage  
bay.

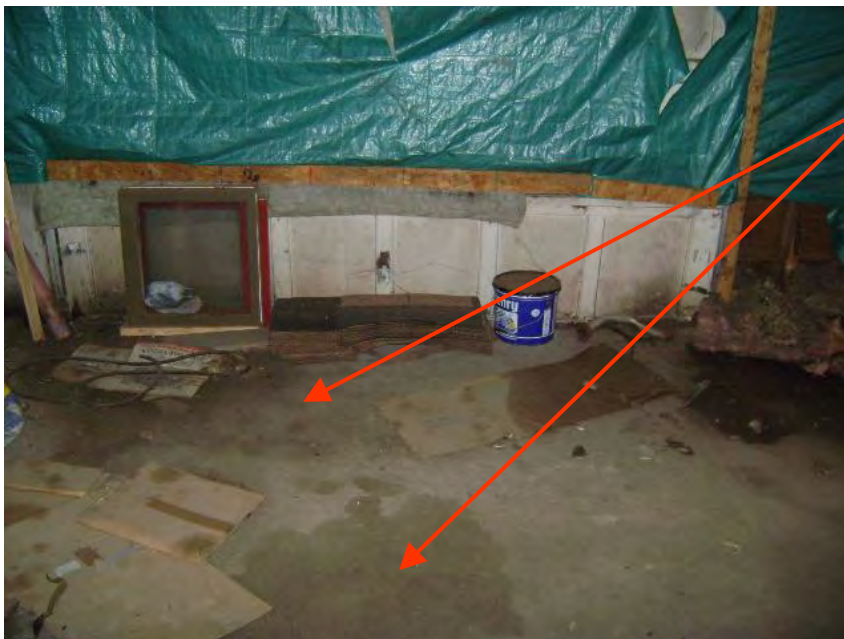
**Picture 18**  
Representative  
view of staining  
observed in the  
garage bay.

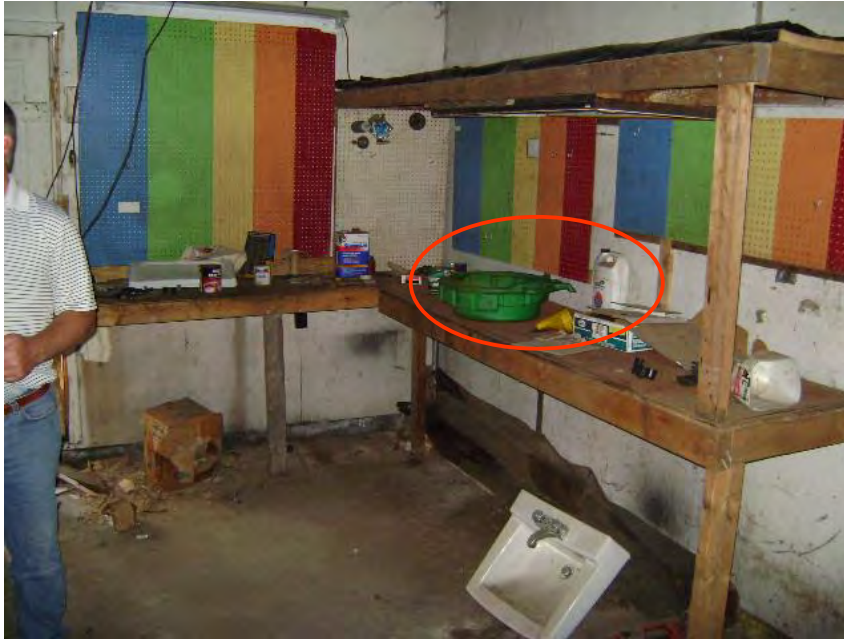
**Picture 19**

Representative view of automotive fluid containers observed in the garage bay.

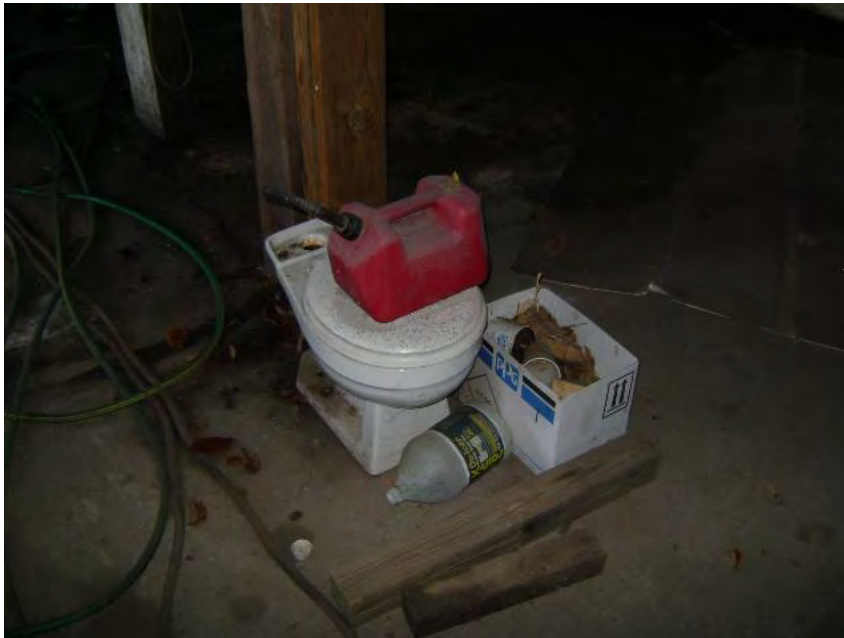
**Picture 20**

Representative view of automotive fluid containers observed in the garage bay.

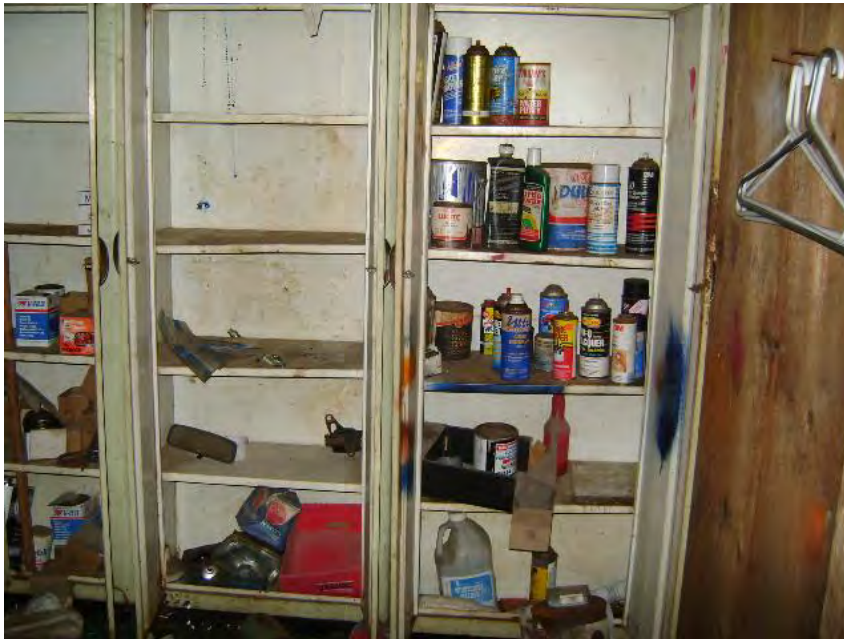
### Picture 23

Representative view of shelves containing automotive cleaning, lubricating, and maintenance fluids and aerosol containers.

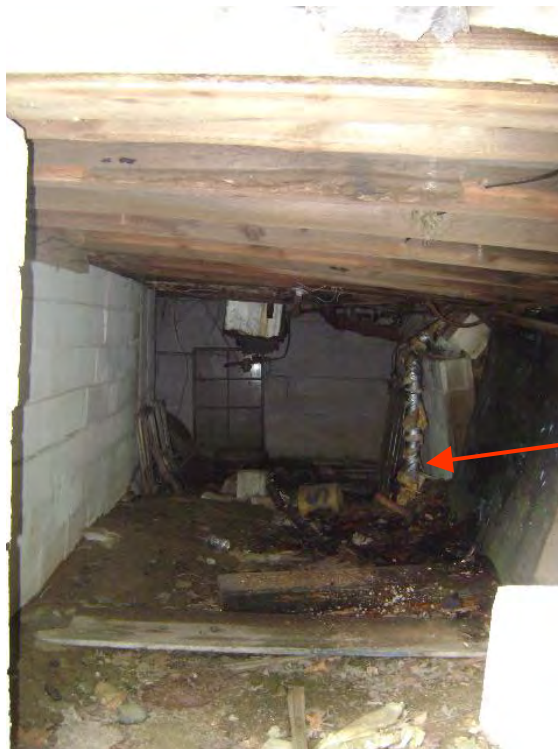
**Picture 26**

The dirt floor crawl space basement is located under the eastern side of the garage building. An insulated pipe was observed going into the ground from the eastern side wall of the crawlspace (**Picture 26**). Though additional investigation is required to determine the nature of this pipe, it is unlikely that it is associated with the bulk storage or release of oil and/or hazardous materials. This feature may potentially be a sewer pipe coming from the cottage located adjacent to the garage building.

Representative view of the crawlspace below the garage building.

(Note the insulated pipe on the right side.)

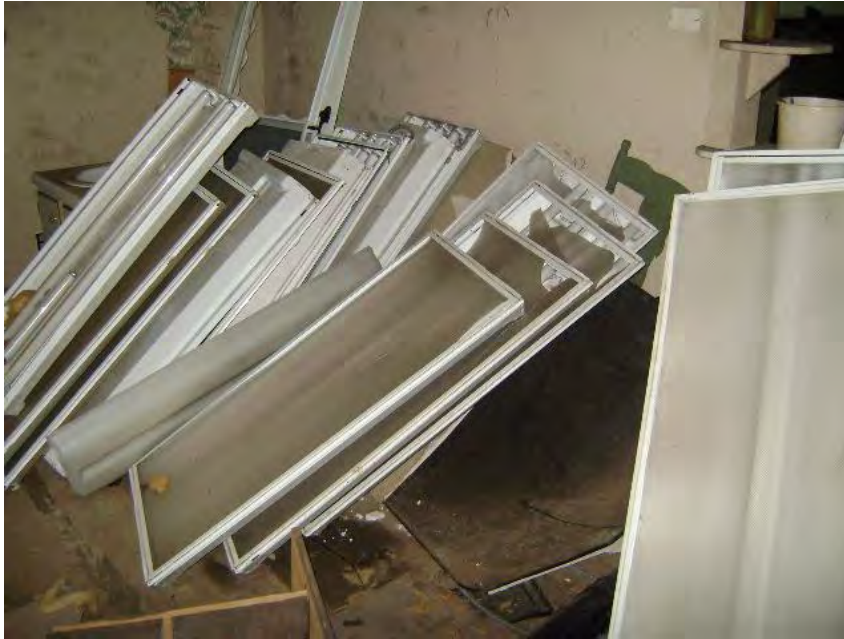
**Picture 29**  
View of the  
fluorescent light  
ballasts observed in  
the cottage.

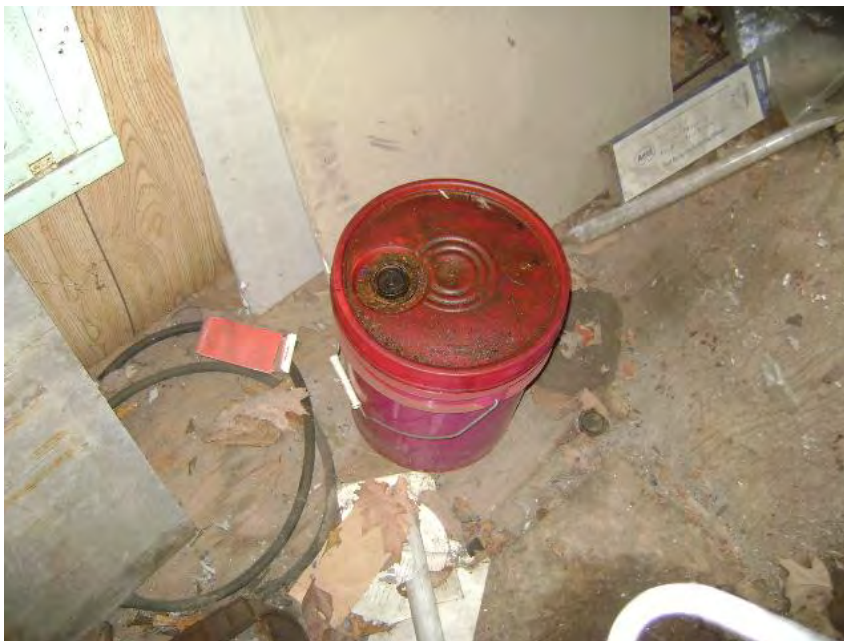
**Picture 30**  
Representative  
view of one of the  
five 5-gallon  
containers of  
unknown contents  
observed in the  
cottage.

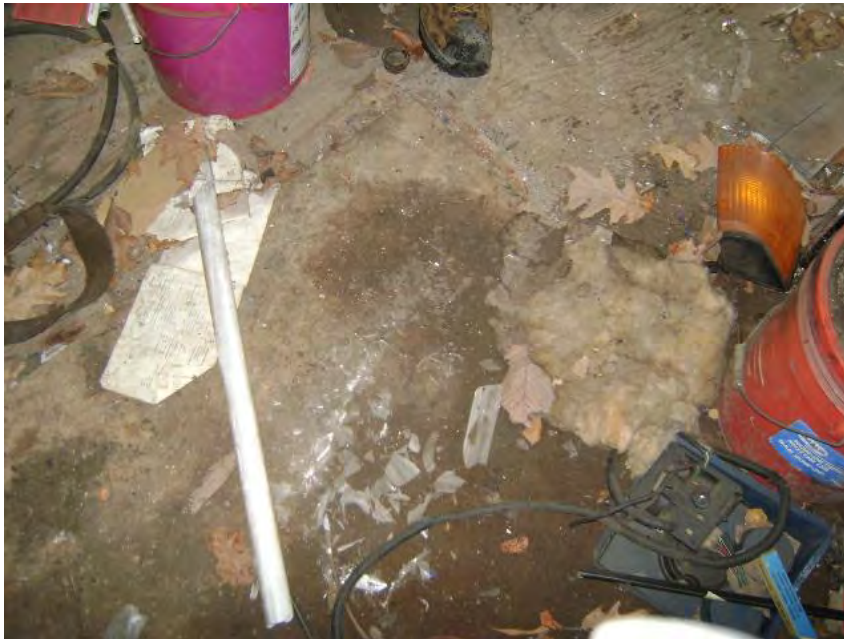
**Picture 31**

- DMEC-1 – Oil staining observed on the floor of the cottage represents a DMEC because it is evidence of a release; however, a pathway to the environment is not likely.
- DMEC-2 – Multiple small volume containers (less than 50-gallons each) of oil, gasoline, and automotive lubricants and cleaning materials represent a DMEC because of the poor

Representative view of the stains observed on the floor of the cottage.

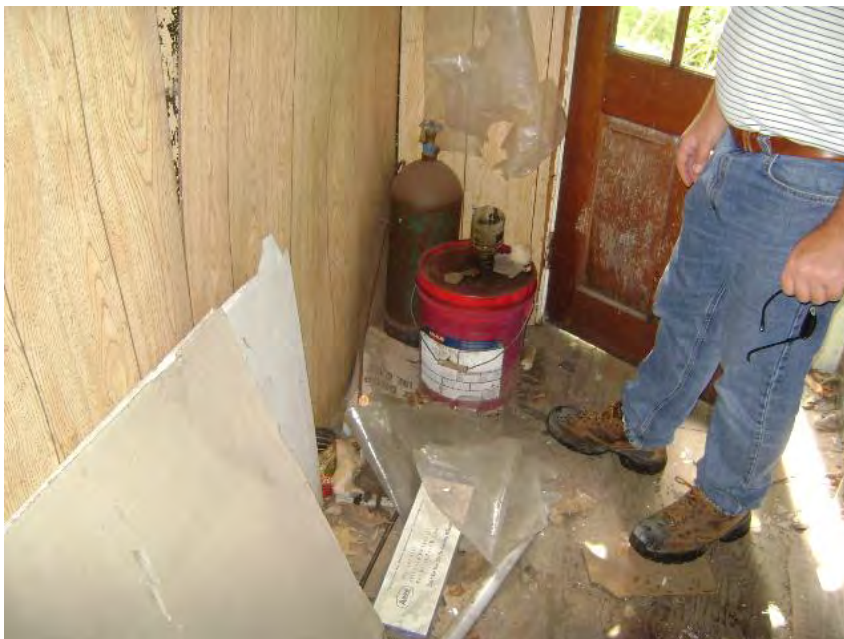
**Picture 32**

View of the gas canister with unidentified contents observed in the cottage.
