PHASE I ENVIRONMENTAL SITE ASSESSMENT

Former L.W. Packard Mill
6 Mill Street
Ashland, New Hampshire
NHDES#200009045
LRPC Brownfields Grant # BF96111801

CREDERE ASSOCIATES, LLC

November 29, 2011

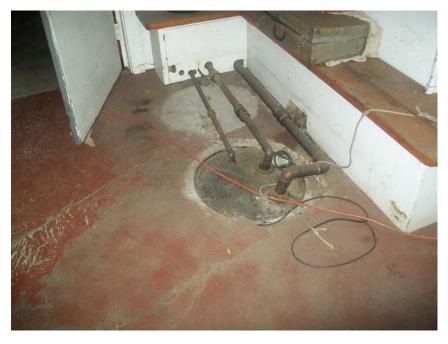
Picture 11
View of condensate sump observed in metal shop.

The northeast portion of the building is in use as a metal fabrication shop and has a loading dock (**Picture 10**). A small sump was observed in this area that according to Mr. Russell was for condensate of the former steam heating system (**Picture 11**). With the exception of consumable quantities of cutting oil and paints (one-gallon or smaller, spray cans, etc.), no petroleum or hazardous materials were observed in the metal shop.

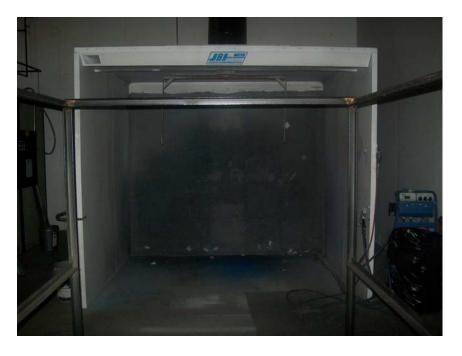
Picture 12
View of Central
Powder Coating
paint booth.

The northwest portion of the building is currently used by Central Powder Coating. Half of the area has been partitioned into a workshop with a paint booth (**Picture 12**), drying booth (**Picture 13**), and sandblasting equipment. The remaining area is used for cold storage. Paints and thinners were observed throughout the area but were well organized. No evidence of leaks or spills was observed in the area. A small transformer room is located to the west of the workshop that contained one large pad mounted transformer (**Picture 14** and discussed in **Section 5.5**). Due to dirt and rainwater infiltration, the concrete floor of this area was obscured from view.

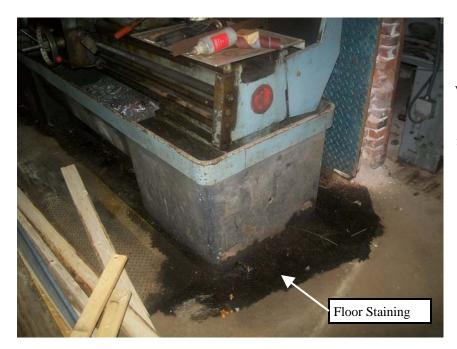
Picture 19

- REC-4 Oil staining observed in the generator building and around the elevator equipment represents a REC because PCBs were historically added to some lubricating and hydraulic oils and may be present in the affected areas in exceedances of regulatory standards.

The metal workshop contained metalworking equipment, tools, and supplies. One (1) 55-gallon drum of lubricating oil was observed in the room. Oil staining was observed on the floor around a cutting/threading machine (**Picture 19**), but the floor appeared intact and there is likely no migration pathway to the environment in this location. No other significant staining was observed in the room.

View of floor staining around metalworking machine in generator building.

- Phase II ESA activities are recommended to confirm or dismiss the above RECs.
- Asbestos, lead-based paint and PCB-containing building materials surveys should be completed to confirm or dismiss the presence of these materials on the subject property. These surveys will also assist with delineating the extent of any of these previously identified materials within the buildings.
- Universal and hazardous waste surveys should be completed to inventory the wastes which are currently present or may be generated at the subject property during redevelopment.

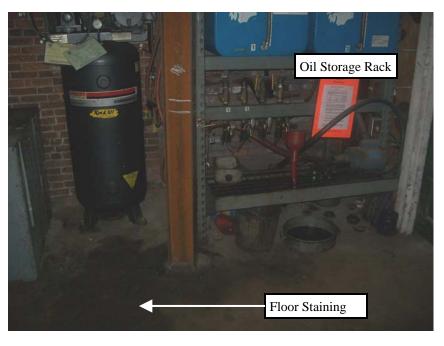
Picture 20

The general work area contained tools, small parts, and furniture. The southeast corner of the work area was used for storage of lubricating oil formerly used by the mill, and hydraulic oil used in turbine maintenance. Four (4) 61-gallon oil totes were located on a rack in this area which had a distribution system and drip pan. Two (2) 55-gallon drums of hydraulic oil with hand pumps were also present in this area. The concrete floor around the dispensing system was stained, but the floor appeared intact and there is likely no migration pathway to the environment in this location (**Picture 20**). Six (6) waste fluorescent lighting ballasts were observed in a pile in the work area. The ballasts were not labeled "non-PCB"; therefore, likely contain PCBs. (**Picture 21**). Intact and in-use fluorescent lighting fixtures are discussed as an ASTM non-scope consideration in **Section 9.4**.

View of floor staining around oil storage rack in generator building.

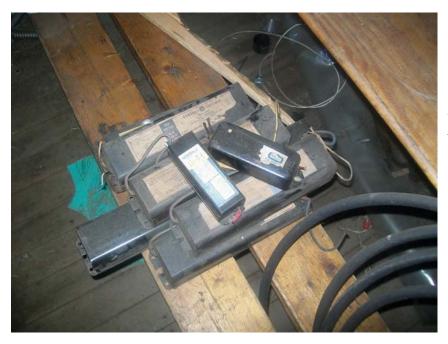
Picture 21

Six (6) potential PCB-containing waste fluorescent lighting ballasts were observed in the generator building. The ballasts appeared to be intact.

View of waste fluorescent lighting ballasts observed in the generator building.

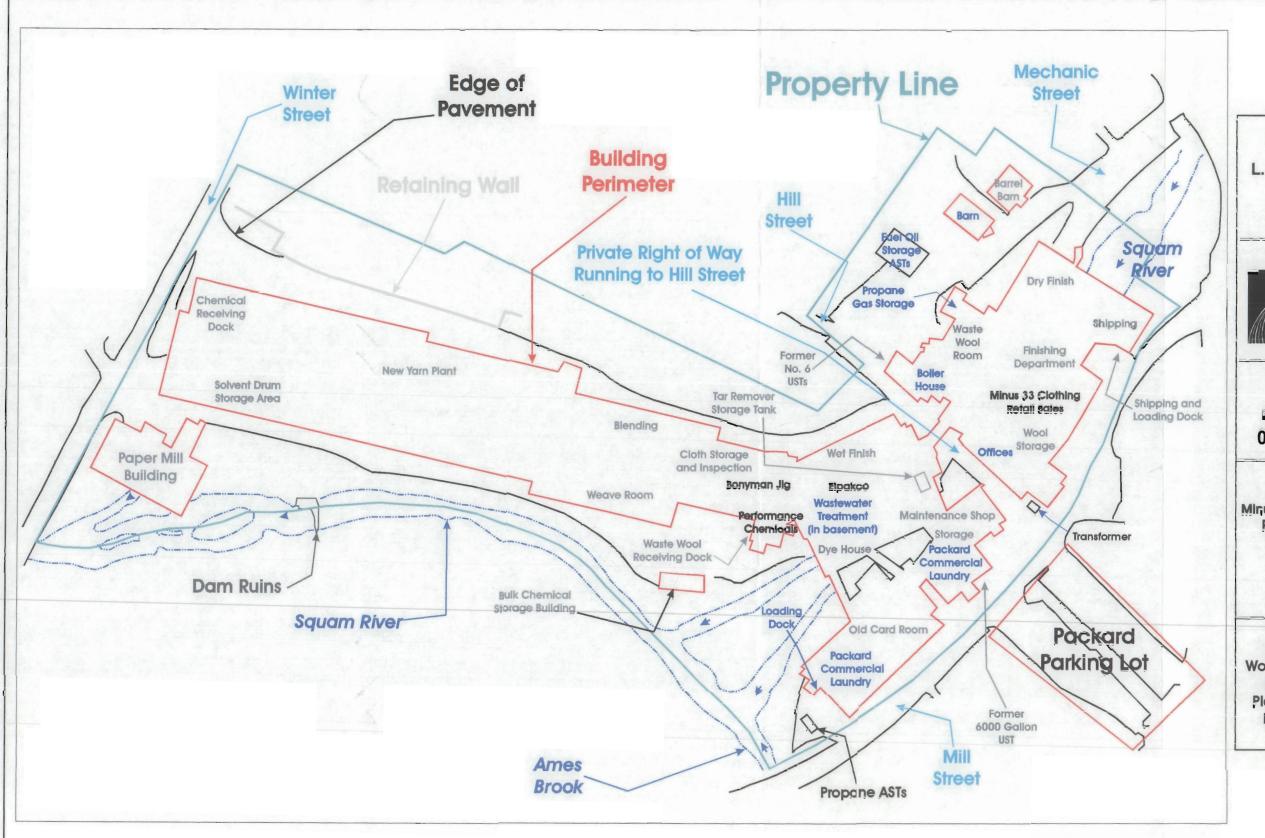
Figure 8 Site Plan L. W. Packard and Company, Inc. **Mill Street** Ashland, New Hampshiree January 2005

Past and Current Building Use

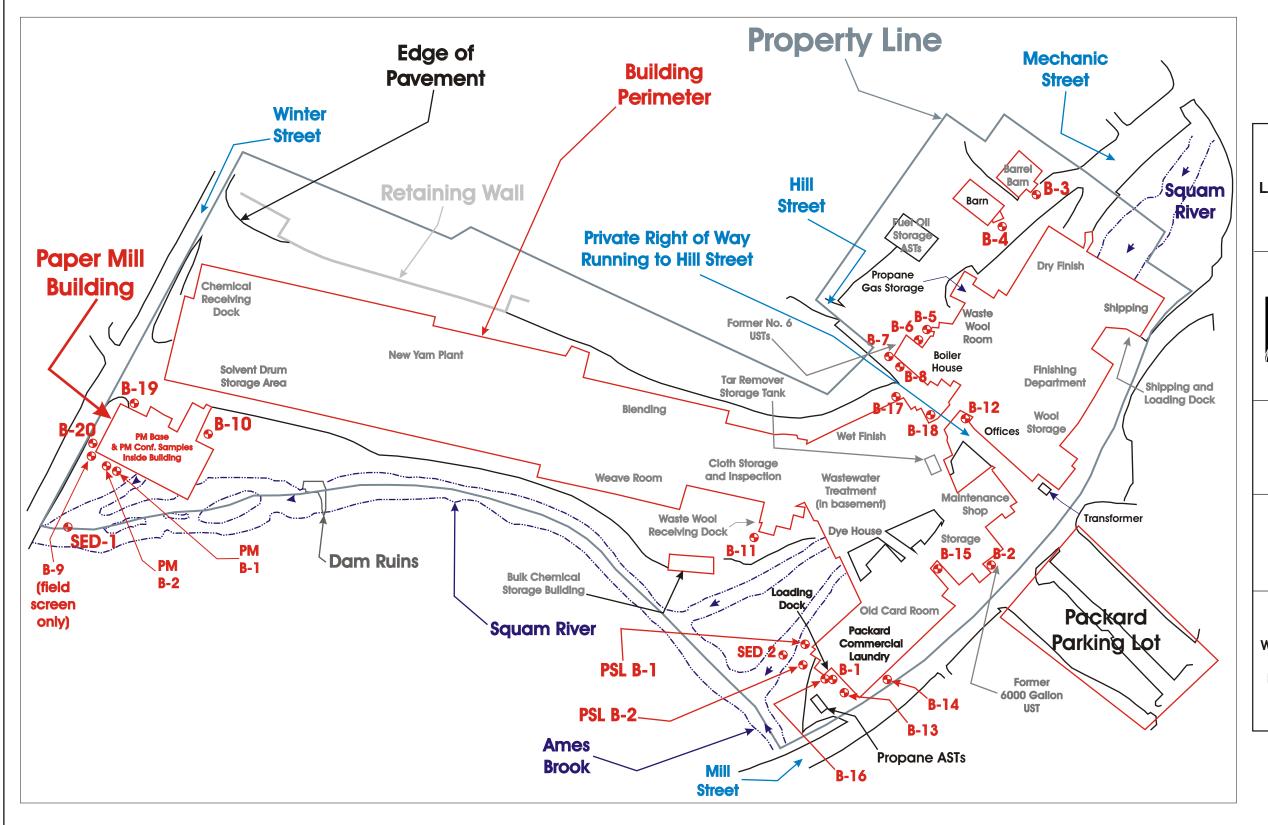
Figure 1
Soil and Sediment
Sample Locations
L. W. Packard and Company, Inc.
Mill Street
Ashland, New Hampshire
May 2006

Soil or Sediment Sample Location
