**PHASE I ENVIRONMENTAL SITE ASSESSMENT**

Mica Building Property  
8 (a.k.a. 5) Central Street  
Bristol, New Hampshire  
DES#200105002

Mica Factory Property  
8 (a.k.a 5) Central Street  
Bristol, New Hampshire  
NH DES #200105002

*In Reference to:*  
**Project No. 10001087**

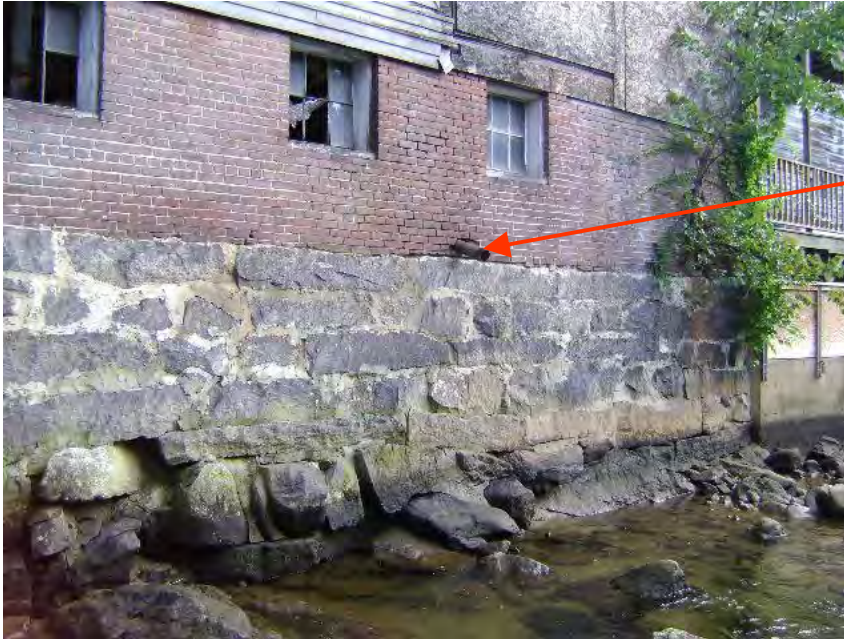
**Picture 3**

View of the pipe protruding from the basement wall.

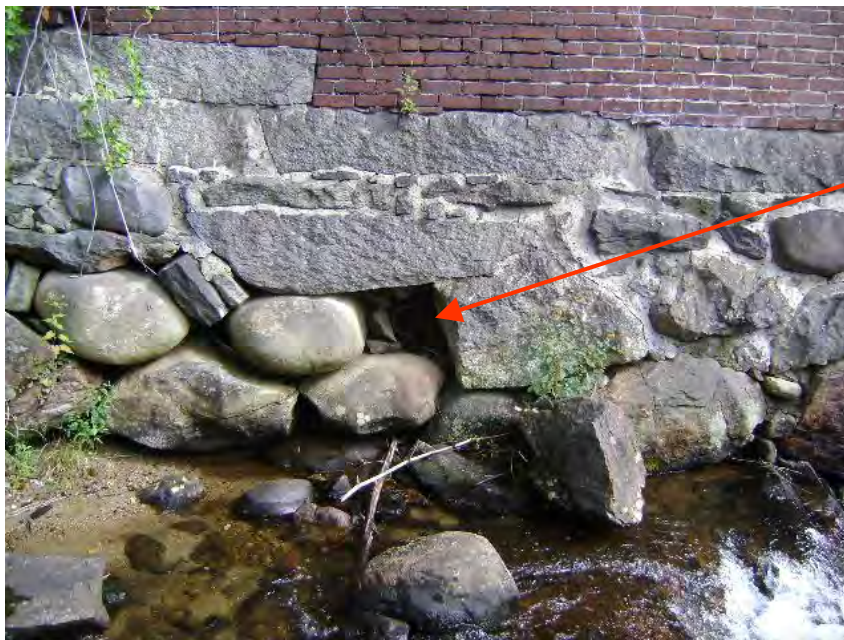
**Picture 4**

View of the pipe flush with the foundation wall on the south side of the building.

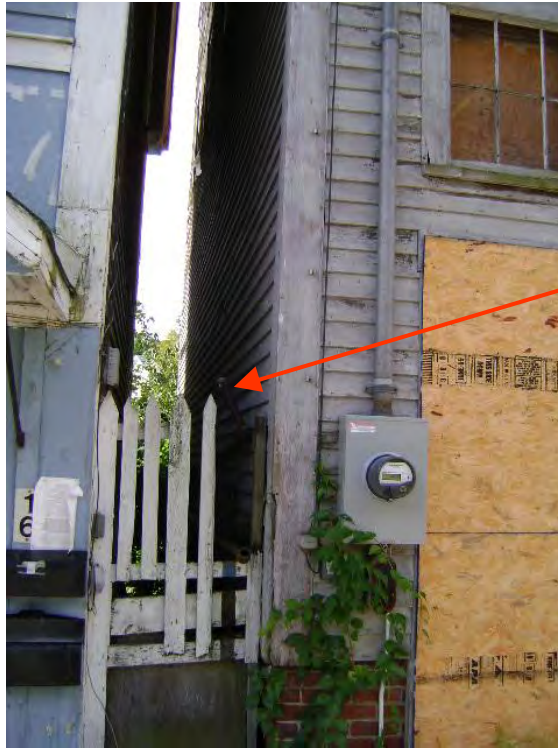
**Picture 5**

View of the fill and vent pipes on the east side of the building.

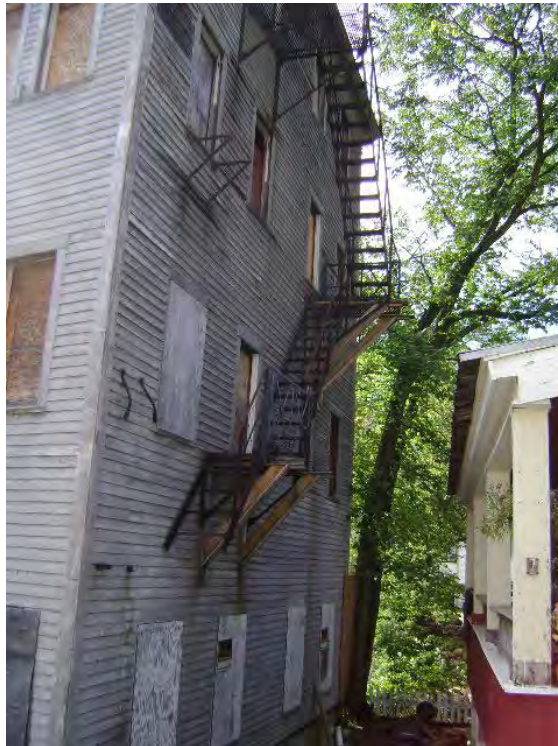
**Picture 6**

View of the fire escape on the west side of the building.

The subject property is a rectangular shaped parcel of land. One (1) four story wooden building with a flat roof and painted wooden clapboard siding occupies the majority of the subject property (**Picture 1**). Portions of the subject property not occupied by the building are narrow alleys between the buildings to the east and west. The south side of the building foundation acts as the edge of the Newfound River (**Picture 2**). Two pipes were observed on the exterior southern wall of the building. One pipe was observed protruding from the basement wall (**Picture 3**). The use of this pipe is unknown. The other pipe was observed flush with the foundation wall (**Picture 4**). Although additional investigation is needed, this pipe may be the outlet for the floor drains. Fill and vent pipes, which likely formerly served the AST in the basement, were observed on the northeast corner of the building (**Picture 5**). The fill and vent pipes entered the building through the eastern wall and were no longer connected to the AST. A metal fire escape is located on the west side of the building (**Picture 6**).

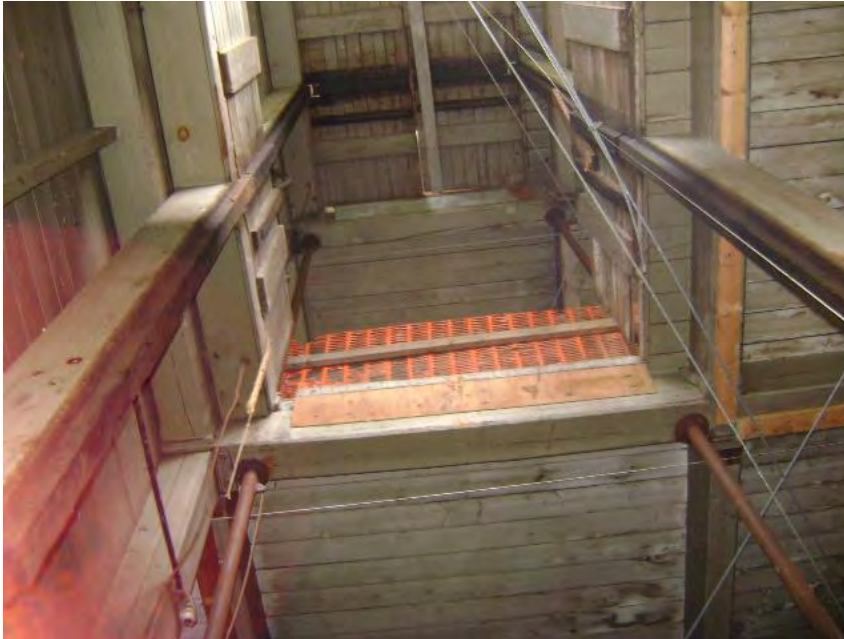
**Picture 7**  
Representative view  
of the  
elevator shaft  
looking up from the  
first floor.

- REC-4 – The presence of an elevator in the building represents a REC. Though the mechanical components have been removed, lubrication and hydraulic fluids may have previously been released from the elevator and may have impacted the environmental conditions of the subject property.

No potential PCB-containing electrical or hydraulic equipment was observed within the limits of the subject property. However, an elevator shaft was observed in the building. All of the elevator components have been removed, thus preventing identification of the characteristics of the elevator, which may have employed hydraulic equipment.

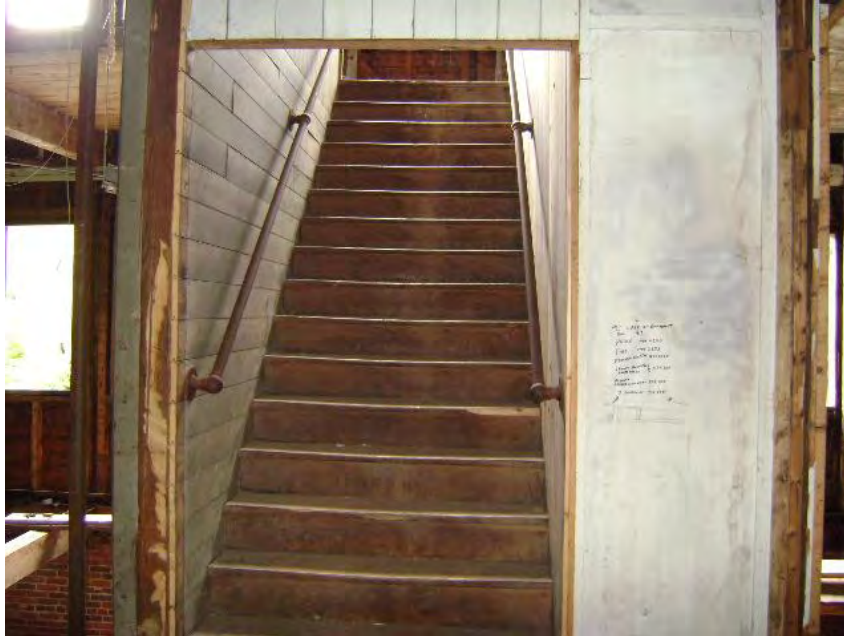
**Picture 8**  
Representative  
view of the  
staircase on the first  
floor.

The interior of the building consists of a full basement and four above-grade stories. An elevator shaft (**Picture 7**) and a staircase (**Picture 8**) are located in the middle of the building. The building is constructed of a wood frame with a stone and brick foundation. Though no structural assessment was completed as part of the ESA, the building appears to be in very poor structural condition as evidenced by the fact that a portion of the roof has collapsed and steel cable bracing has been installed to help support the building (**Picture 9**). The basement floor consists of a combination of concrete, dirt, and bedrock (**Picture 10**). The floors in the above-grade stories are wooden (**Picture 11**).

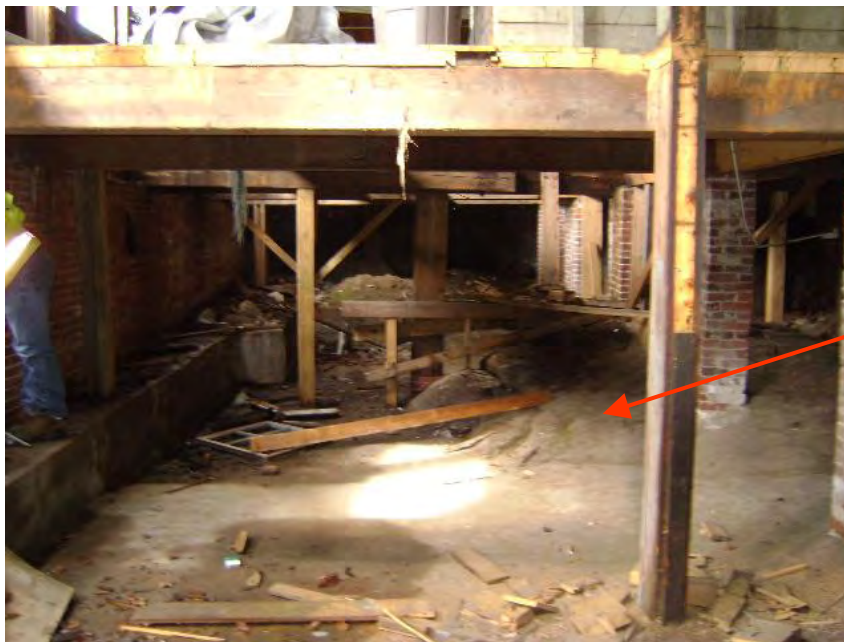
**Picture 10**  
Representative  
view of the  
basement looking  
west.

Note the bedrock in  
the basement

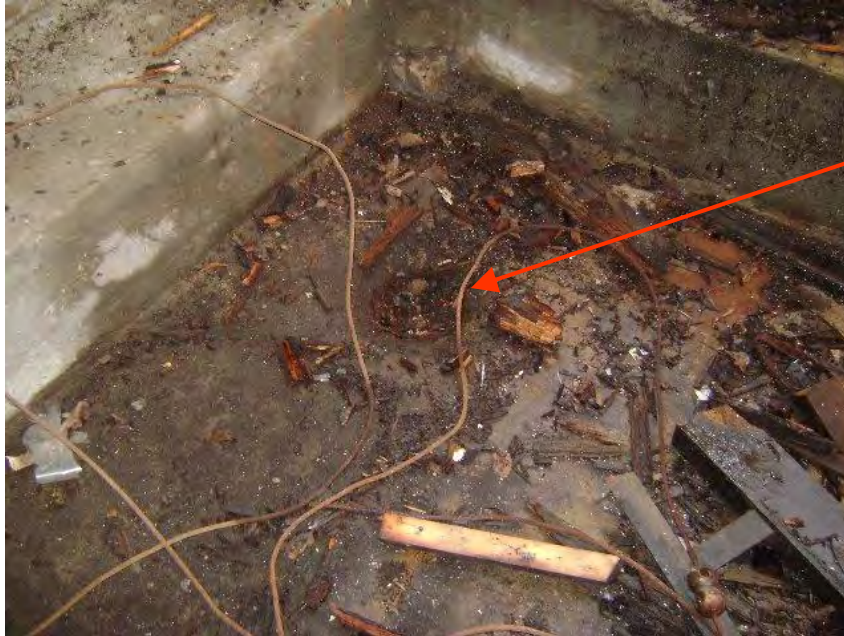
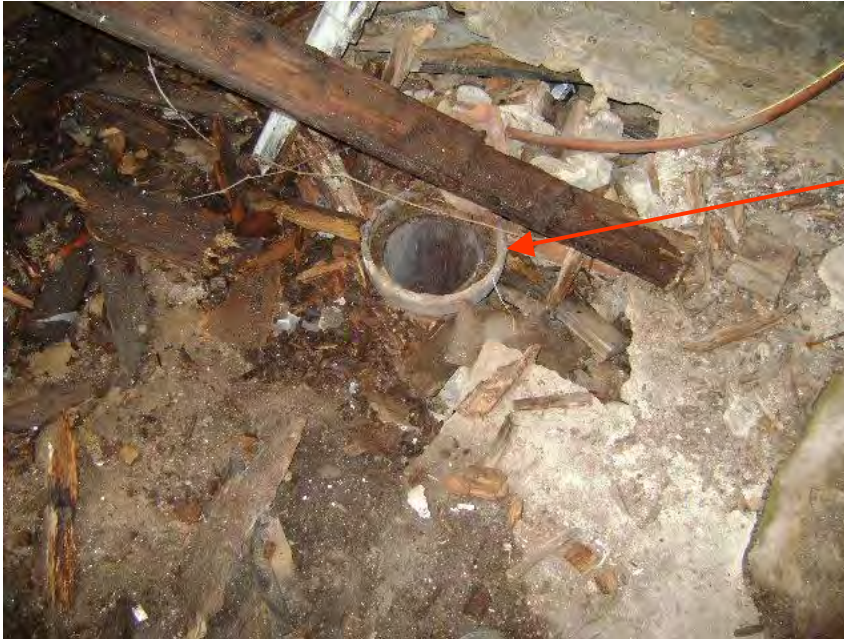
**Picture 12**  
View of the eastern  
floor drain in the  
basement.

- REC-3 – Two floor drains were observed in the basement of the building. The presence of these drains and the previous industrial usage of the building represent a REC because the drains may be conduits to the environment whereby any releases of petroleum products and/or hazardous substances may have impacted the environmental conditions at the subject property.

Two (2) floor drains were observed on the south side of the basement (**Pictures 12 and 13**). Water on the floor prevented identification of staining in the vicinity of the floor drains. No olfactory evidence of releases of petroleum products or hazardous materials was observed in the vicinity of the floor drains. One (1) pipe was observed protruding through the south wall of the basement (**Picture 14**). This is one of the same pipes that were observed on the exterior of the southern wall. The purpose of this pipe is unknown.

View of the western  
floor drain in the  
basement.

- Phase II investigation activities are recommended to confirm or dismiss the above RECs and/or other storage or releases of petroleum products and/or hazardous substances that may have impacted the environmental conditions at the subject property.
- A lead-based paint survey should be completed to confirm or dismiss the presence of lead-based paint on the exterior of the building.
- If the building will be re-used, a mold survey should be completed to identify the presence of potential hazardous molds within the building.
- Universal wastes that may be generated during potential building demolition or renovation activities should be properly consolidated and disposed of in accordance with local, state, and/or federal guidelines.

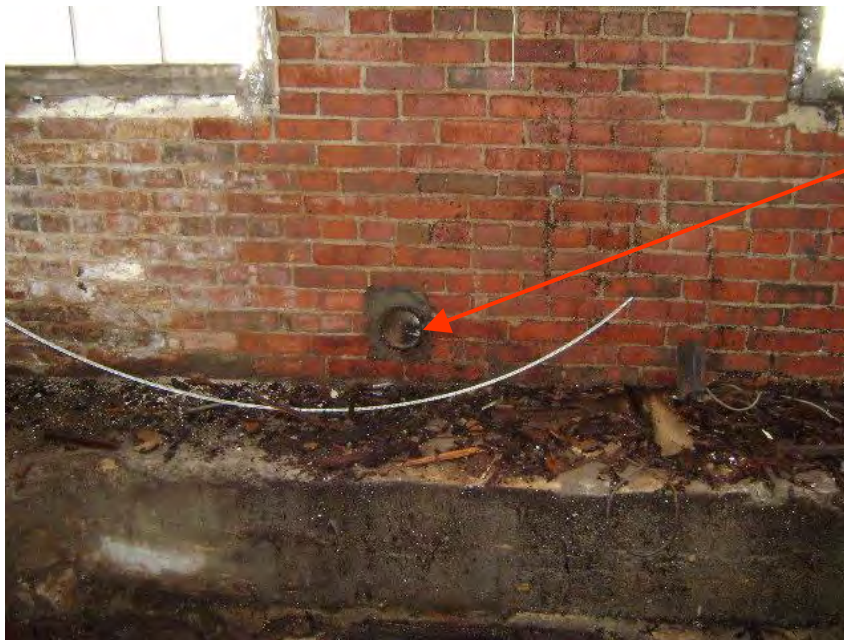
**Picture 14**

View of the pipe  
through the  
southern wall of the  
basement

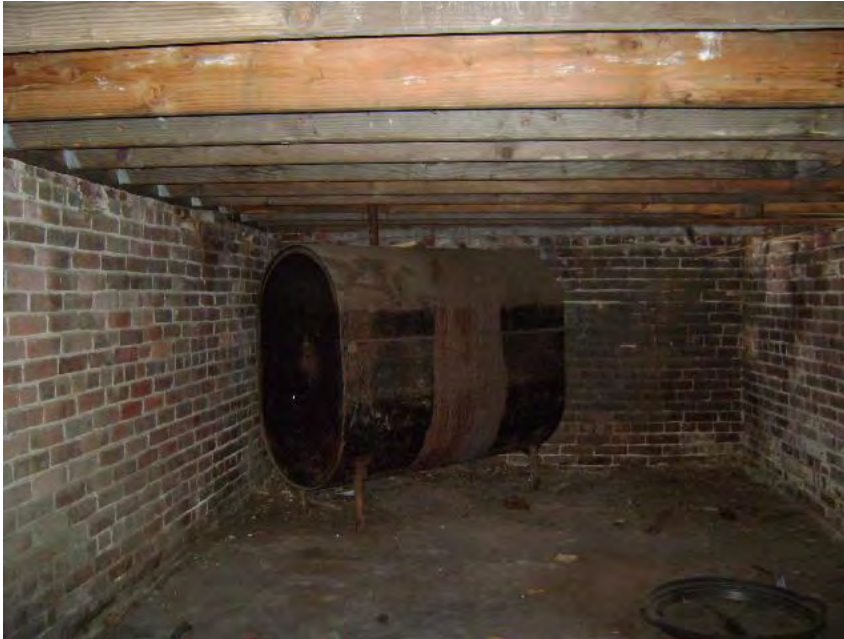
**Picture 15**  
View of the 275-  
gallon AST  
observed in the  
southeast corner of  
the basement.

One (1) 275-gallon AST, which appeared to be empty, was observed in the southeast corner of the basement (**Picture 15**). No visual or olfactory evidence of a release was observed on or

around the AST. Fill and vent pipes were observed entering the building through the eastern wall in the vicinity of the AST, but the pipes were not connected to the AST.

One (1) 275-gallon AST is located in the southeastern corner of the basement (**Picture 15**). No visual or olfactory evidence of a release was observed on or around the AST. Fill and vent pipes were observed entering the building through the eastern wall in the vicinity of the AST, but the pipes were not connected to the AST.

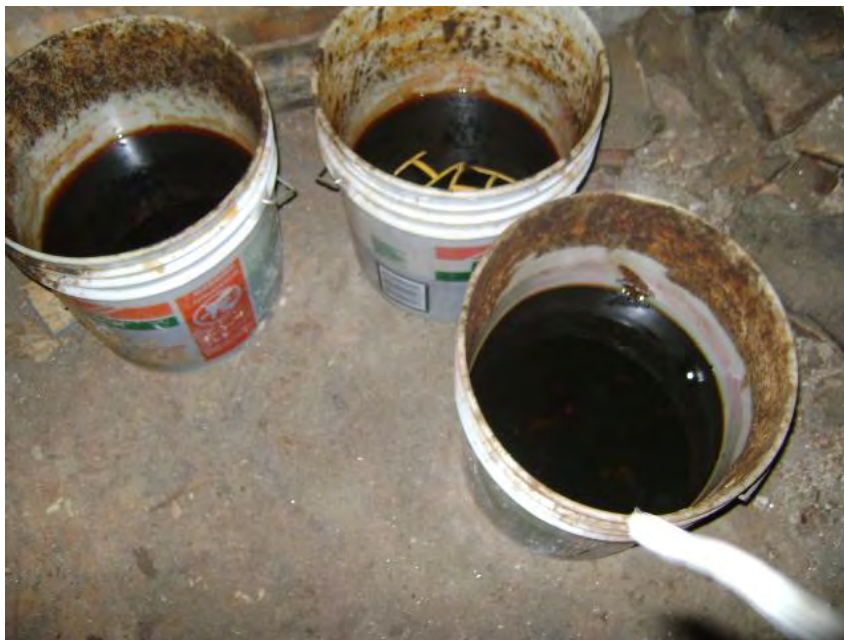
**Picture 16**  
View of the three  
5-gallon buckets of  
waste oil in the  
northeast corner of  
the basement.

Three (3) half-full 5-gallon pails of what appeared to be waste oil were observed in the northeast corner of the basement (**Picture 16**). These pails are unsealed and unsecured, thus representing a probable release.

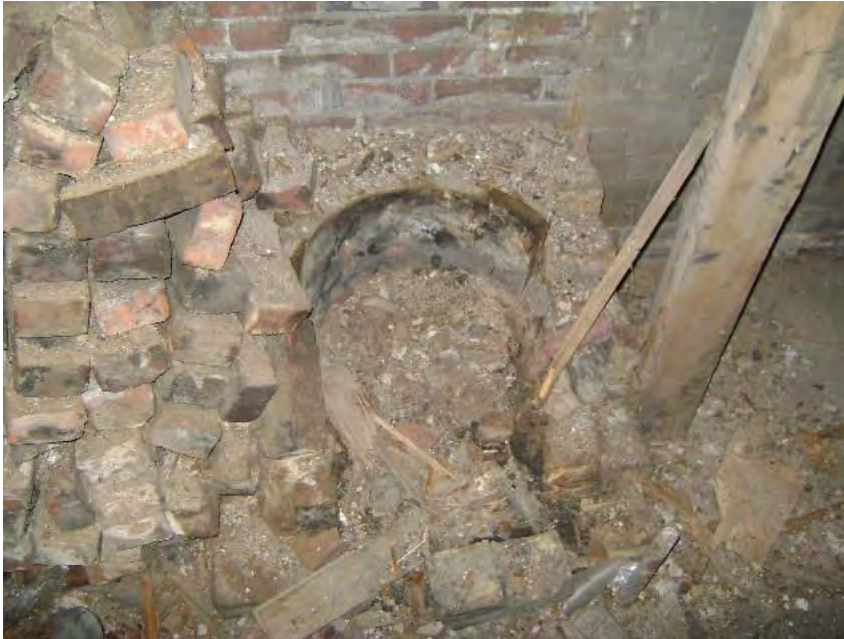
**Picture 17**

The location of the former chimney was observed in the basement along the eastern wall (**Picture 17**).

View of the location of the former chimney on the eastern wall of the basement.

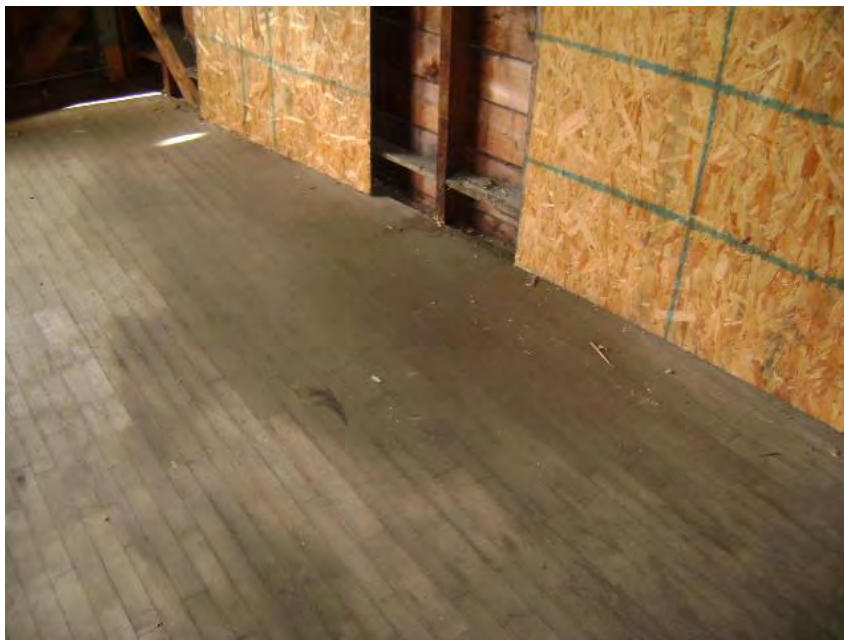
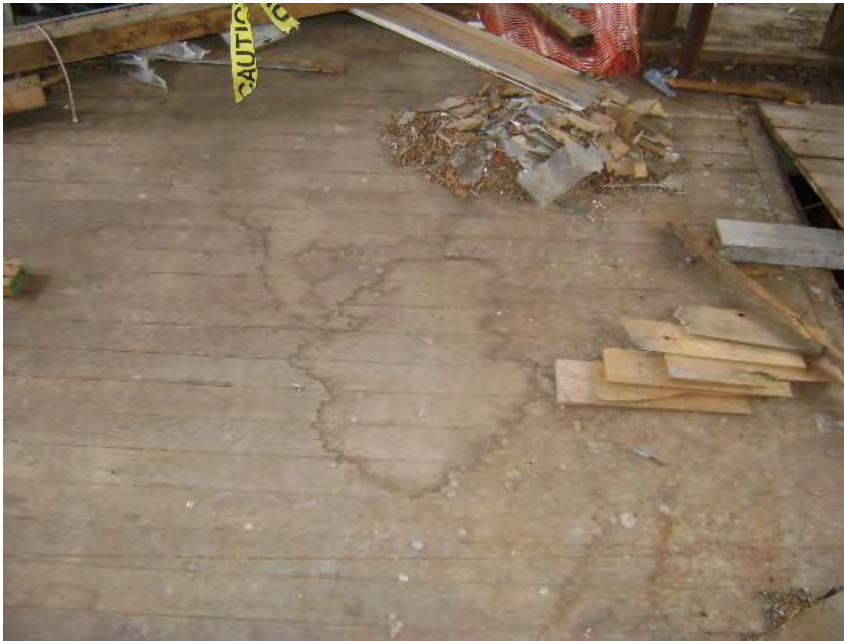
**Picture 18**

- REC-7 – The presence of unknown staining on the floors of the building represents a REC because the stains are indicative of a potential past release of petroleum products and/or hazardous substances which may have impacted the building structure and environmental conditions of the subject property.

Stains caused by unknown substances were observed on the wooden floors on the second and third stories of the building (**Pictures 18 and 19**).

Representative view of one of the stains observed on the floor of the second story.

Representative view of the one of the stains observed on the floor of the third story.

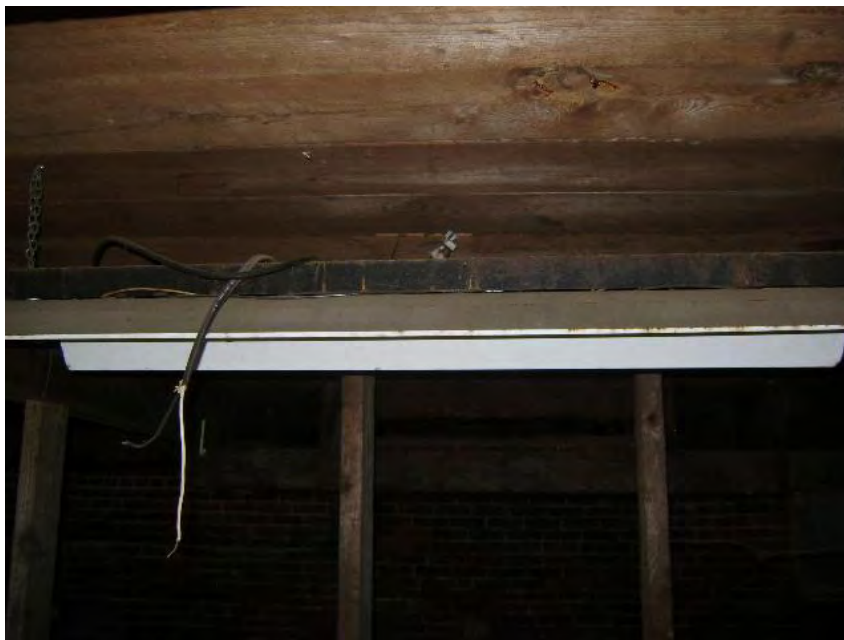
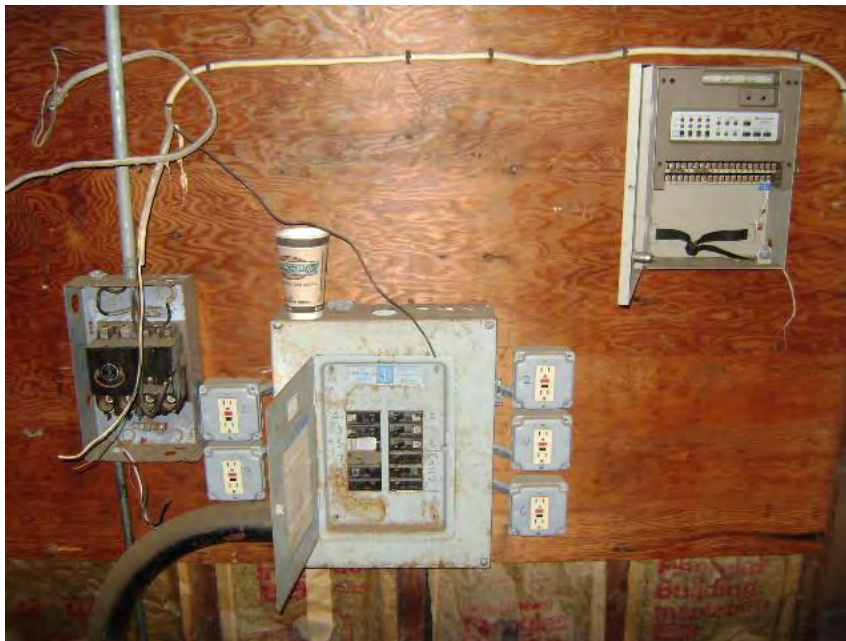
**Picture 20**

Multiple fluorescent light bulbs, light ballasts, electrical switches, and circuit breakers were observed on all levels of the building (**Pictures 20 and 21**).

ASTM Standards for Phase I ESAs specifically exclude fluorescent lighting fixtures that may contain PCBs from electrical equipment unless they are found in waste form. Fluorescent lighting fixtures that were not in waste form were observed in the building and are discussed as a non-scope consideration in **Section 10.4**.

Representative view of one of the fluorescent light fixtures in the building.

**Picture 21**  
Representative  
view of the  
electrical  
equipment located  
in the building.
