### VIII. NATIONAL REGISTER NOMINATION

#### Historic Resources Inventory Holderness - 1983

HISTORIC RESOURCE INVENTORY  
Lakes Region Planning Commission  
Meredith, New Hampshire

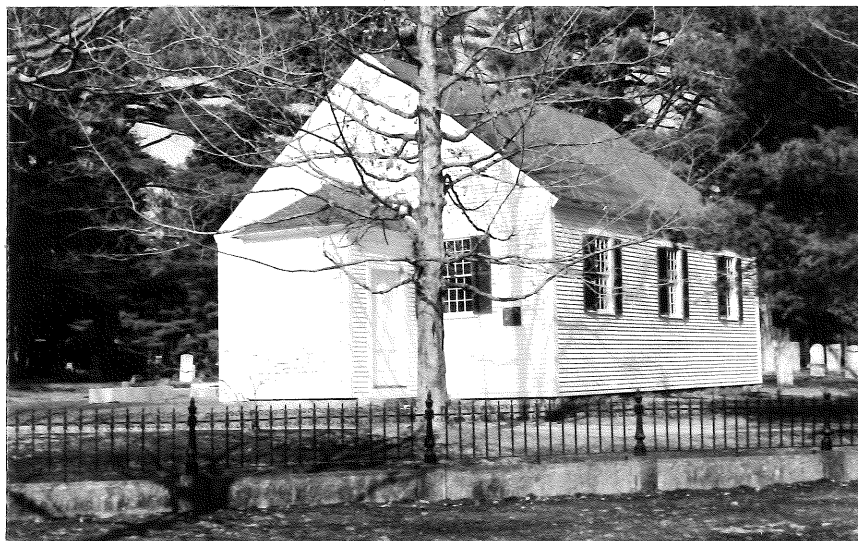
PHOTO:

CONDITION: Exc. ☒ Good ☐ Fair ☐ Poor ☐ Ruins ☐

COMMENTS: Well preserved 18th century interior, with pews and pulpit.

1. STYLE: Vernacular BUILDING TYPE: church
2. # STORIES: 1 DIMENSIONS: 28 x 36 BAYS: 3 x 3 FORM: rectangular plan
3. FOUNDATION: granite block 4. STRUCTURE: wooden frame

5. WALLS: Sheathing clapboards Ornamentation: cornerboards
6. ROOF: Type gable Sheathing asphalt shingles  
Dormers/Cupolas                      Details
7. CHIMNEYS: #                      Location                      Materials                       
Description

8. EAVES TREATMENT: Lateral                      close eaves  
Gable End                      close verges
9. WINDOWS: Placement symmetrical Shape rectangular Sash 12/12  
Surrounds plain trim, louvred shutters

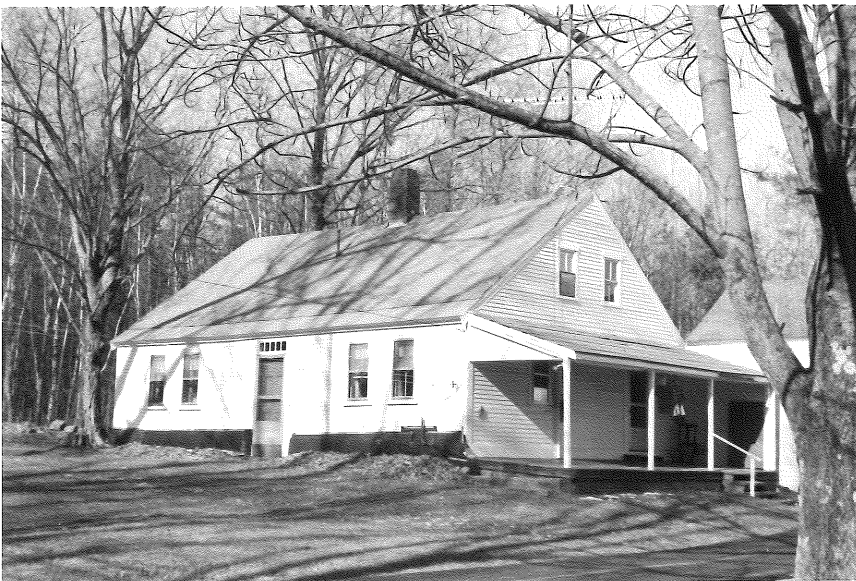
PHOTO:

CONDITION: Exc. Good Fair X Poor    Ruins

COMMENTS: Interesting interior woodwork, notably fireplace surrounds and Indian  
shutters.

1. STYLE: early Cape BUILDING TYPE: house
2. # STORIES: 1 1/2 DIMENSIONS: 37 x 29 BAYS: 5 x 2 FORM: Cape
3. FOUNDATION: cut granite block 4. STRUCTURE: wooden frame

5. WALLS: Sheathing clapboards Ornamentation: asphalt shingles
6. ROOF: Type \_\_\_\_\_ Sheathing \_\_\_\_\_  
Dormers/Cupolas \_\_\_\_\_ Details \_\_\_\_\_

7. CHIMNEYS: # 1 Location center, ridge Materials brick  
Description tapering cap
8. EAVES TREATMENT: Lateral S - shallow moulded cornice; N - close eaves  
Gable End close verges

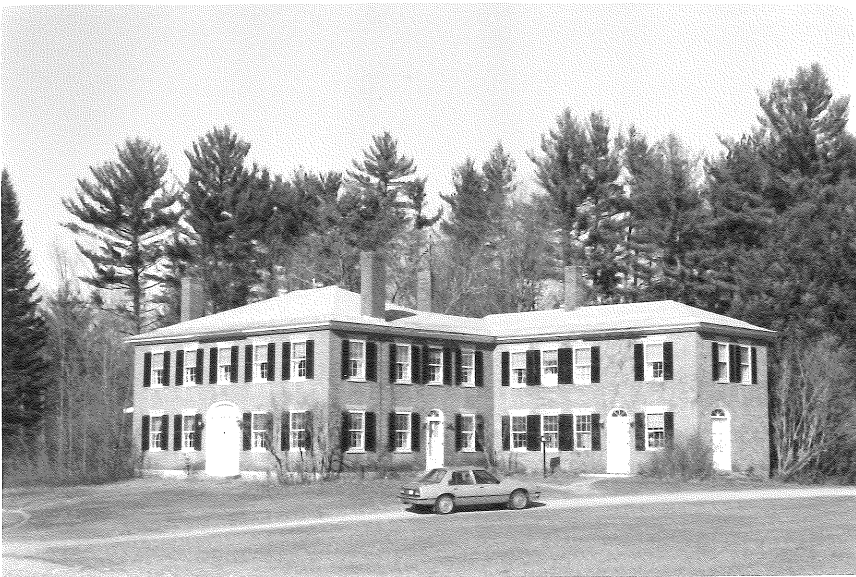
PHOTO:

1. STYLE: Federal BUILDING TYPE: house
2. # STORIES: 2 DIMENSIONS: 40 x 32 BAYS: 5 x 4 FORM: house
3. FOUNDATION: cut granite block 4. STRUCTURE: brick common bond

5. WALLS: Sheathing brick, common bond Ornamentation:
6. ROOF: Type hip Sheathing asphalt shingles  
Dormers/Cupolas  Details
7. CHIMNEYS: # 4 Location interior, walls Materials brick  
Description tall, corbeled caps

8. EAVES TREATMENT: Lateral wooden box cornice with mouldings and frieze  
Gable End wooden box cornice with mouldings and frieze
9. WINDOWS: Placement symmetrical Shape rectangular Sash 6/6  
Surrounds stone sills and lintels, louvred shutters

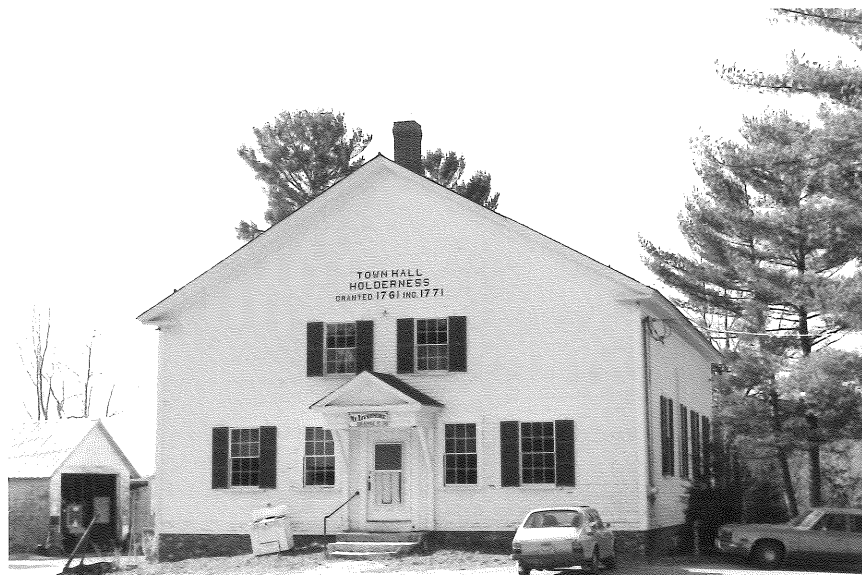
PHOTO:

CONDITION: Exc. Good ☒ Fair Poor Ruins

A new basement with town offices built under the Town Hall - 1974

1. STYLE: Vernacular BUILDING TYPE: Town Hall
2. # STORIES: 1 DIMENSIONS: 44 x 56 BAYS: 5 x 4 FORM: rectangular plan
3. FOUNDATION: brick 4. STRUCTURE: wooden frame

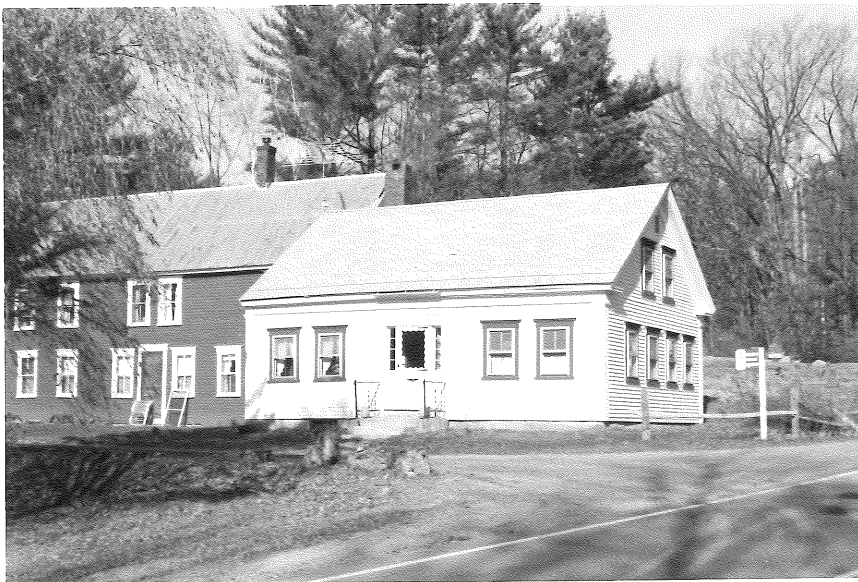
PHOTO:

1. STYLE: Vernacular BUILDING TYPE: house
2. # STORIES: 1 1/2 DIMENSIONS: 32 x 25 BAYS: 5 x 4 FORM: cape
3. FOUNDATION: cut granite block 4. STRUCTURE: wooden frame

17. ARCHITECTURAL IMPORTANCE/INTEGRITY: Typical of the 19th century capes to be found in Holderness.
18. SITE INTEGRITY Marks historic edge of the village.
19. HISTORIC ASSOCIATIONS: Probably built for Ben Piper.

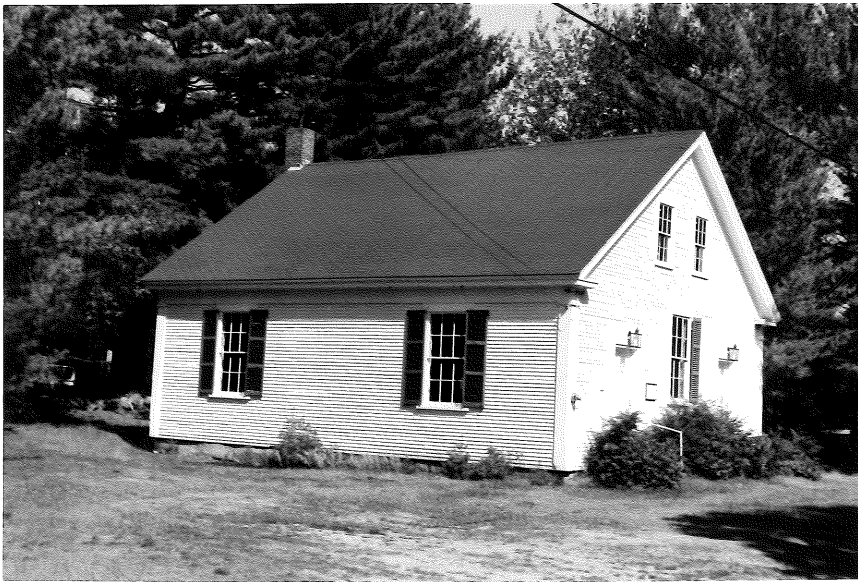
PHOTO:

1. STYLE: Vernacular BUILDING TYPE: church
2. # STORIES: 1 1/2 DIMENSIONS: 35 x 40 BAYS: 3 x 2 FORM: rectangular plan
3. FOUNDATION: cut granite block 4. STRUCTURE: wooden frame

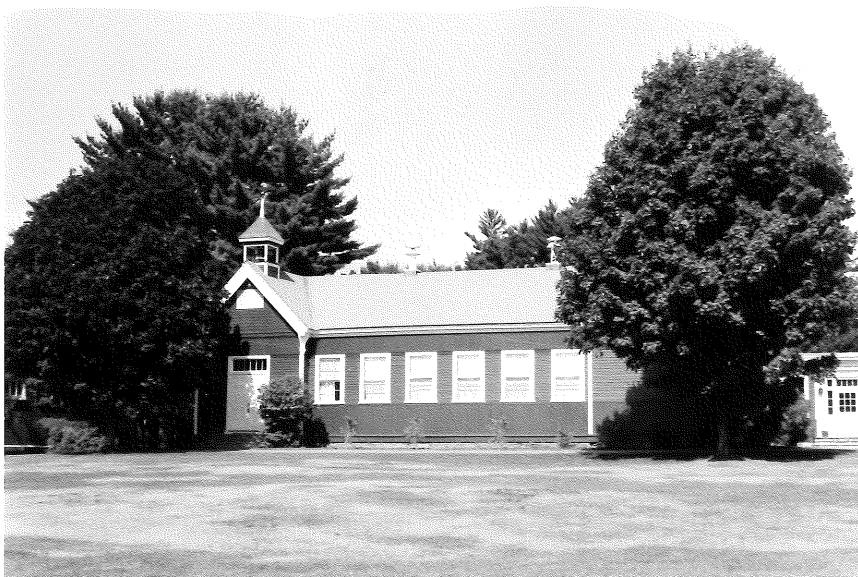
PHOTO:

COMMENTS: After the destruction by fire of Holderness School's original building on  
March 31, 1883, a permanent brick building (which later burned and this "temporary"  
wooden buildings were erected. The Schoolhouse may have been designed by the architect  
of the brick building, W.P. Wentworth of Boston.

1. STYLE: Victorian vernacular BUILDING TYPE: school
2. # STORIES: 1 DIMENSIONS: 78 x 56 BAYS: 8 x 6 FORM: rectangular plan
3. FOUNDATION: fieldstone (concrete - N) 4. STRUCTURE: wooden frame

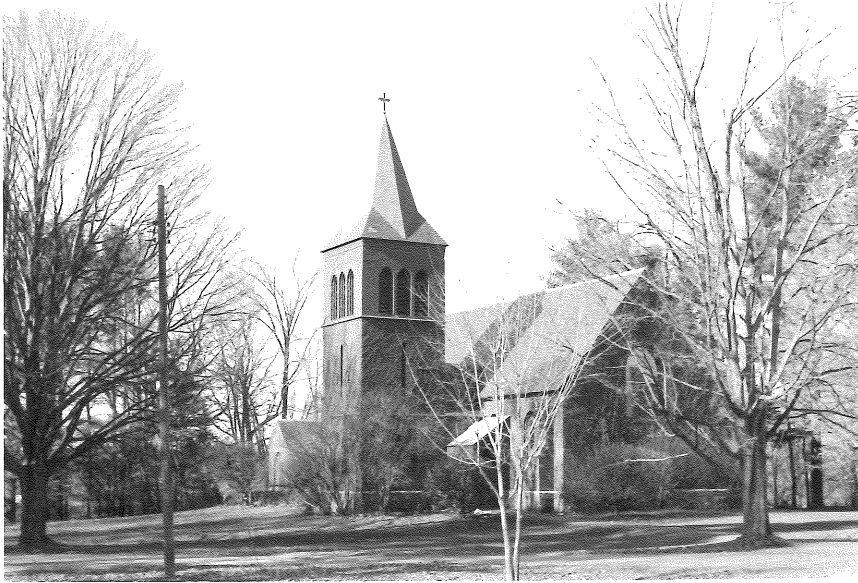
PHOTO:

COMMENTS: Contractors were Head & Dowst of Manchester. Cornerstone laid June 16, 1884. Consecrated October 29, 1884.

1. STYLE: Gothic Revival BUILDING TYPE: church
2. # STORIES: 1 DIMENSIONS: 26 x 80 BAYS: asym. FORM: rectangular plan
3. FOUNDATION: high granite block w/water table STRUCTURE: brick, common bond, flemish var.

9. WINDOWS: Placement symmetrical Shape lancet, trefoil Sash stained glass  
Surrounds stone sills, compound brick Gothic arches, (trefoil-paired or triple w/multi-foil window

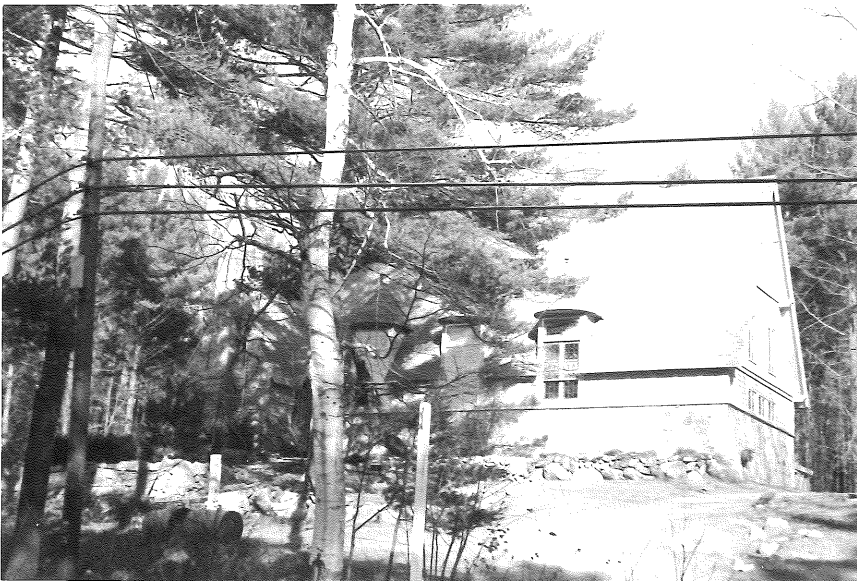
PHOTO:

COMMENTS: First service held July 21, 1889. Consecrated August 19, 1903. The con-  
tractors were Mead, Mason & Co. of Concord, who subcontracted the masonry to Smith  
~~SURVEYORS~~ Bros. of Plymouth. DATE: \_\_\_\_\_  
PHOTOGRAPHER: \_\_\_\_\_

1. STYLE: Victorian BUILDING TYPE: church
2. # STORIES: 1 1/2 DIMENSIONS: 28 x 60 BAYS: 4 x 2 FORM: rectangular plan
3. FOUNDATION: fieldstone 4. STRUCTURE: fieldstone walls, wooden frame
5. WALLS: fieldstone, beneath pebble fieldstone-guinoins & cornerstone
6. ROOF: Type gable Sheathing asphalt shingles
7. CHIMNEYS: # 1 Location exterior, NW gable end Materials fieldstone
8. EAVES TREATMENT: Lateral steeply pitched overhanging eaves, exposed rafters
9. WINDOWS: Placement symmetrical Shape rectangular Sash stained glass
10. ENTRIES-MAIN: Location in vestibule SE facade Door paneled door w/windows
11. PORCHES/HOODS: # 1 Style/Roof Type open wooden deck
12. ELLS WINGS: # 3 Letter on map Stories A 1 B 1 C 1 Bays A 1x2 B 1x1 C 1x1

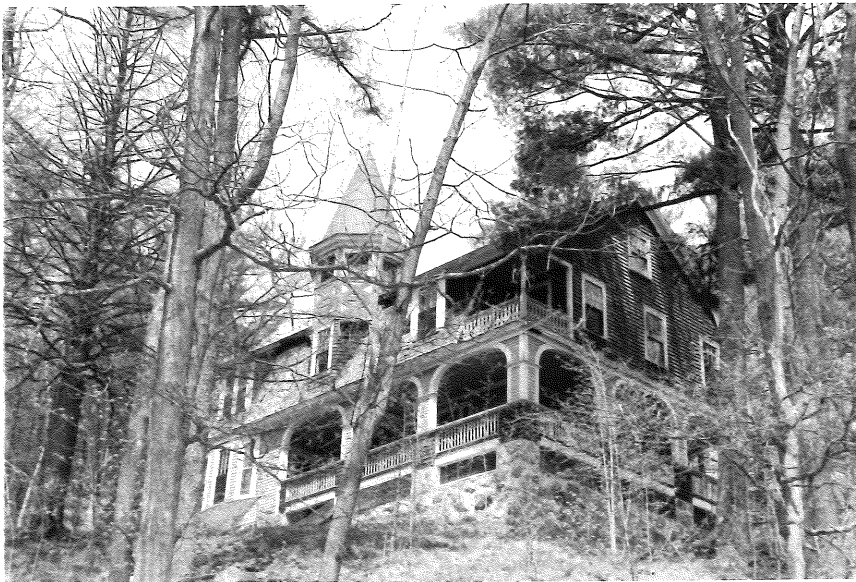
PHOTO:

CONDITION: Exc. Good Fair X Poor \_\_\_\_\_ Ruins \_\_\_\_\_

1. STYLE: late Victorian BUILDING TYPE: house
2. # STORIES: 2 1/2 DIMENSIONS: 36 x 53 BAYS: asym. FORM: rectangular plan
3. FOUNDATION: fieldstone 4. STRUCTURE: wooden frame

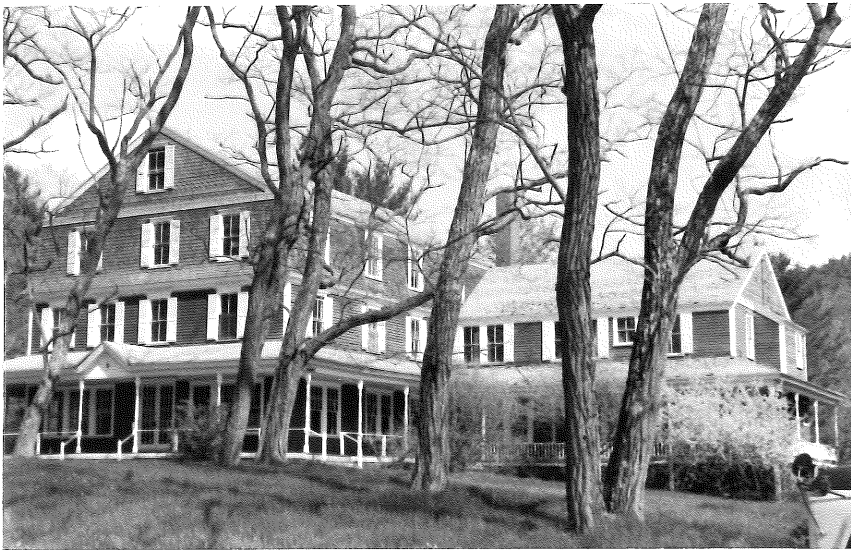
PHOTO:

CONDITION: Exc. Good ☒ Fair Poor Ruins

1. STYLE: Victorian vernacular BUILDING TYPE: hotel
2. # STORIES: 2 1/2 DIMENSIONS: 38 x 54 BAYS: 3 x 4 FORM: rectangular plan
3. FOUNDATION: brick 4. STRUCTURE: wooden frame

18. SITE INTEGRITY One of the most prominent buildings in the village.
19. HISTORIC ASSOCIATIONS: Built as the Central House for and by John S. Davison to replace  
earlier hotel that burned June 3, 1895. Opened in July 1896. Remained in the family  
until acquired by Science Center.

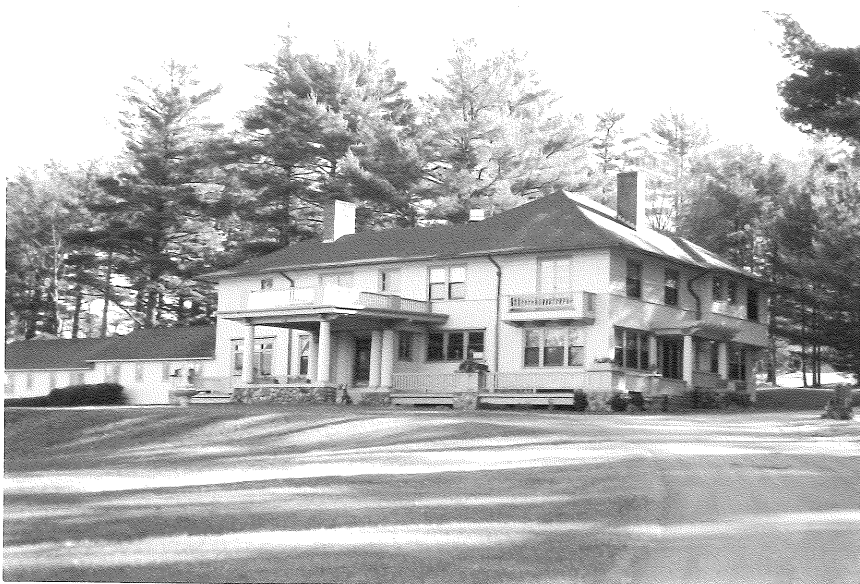
PHOTO:

CONDITION: Exc.    Good X Fair    Poor    Ruins

1. STYLE: 20th century eclectic BUILDING TYPE: house
2. # STORIES: 2 1/2 DIMENSIONS: 48 x 78 BAYS: asym. FORM: L-shaped plan skewed wing
3. FOUNDATION: fieldstone 4. STRUCTURE: balloon frame

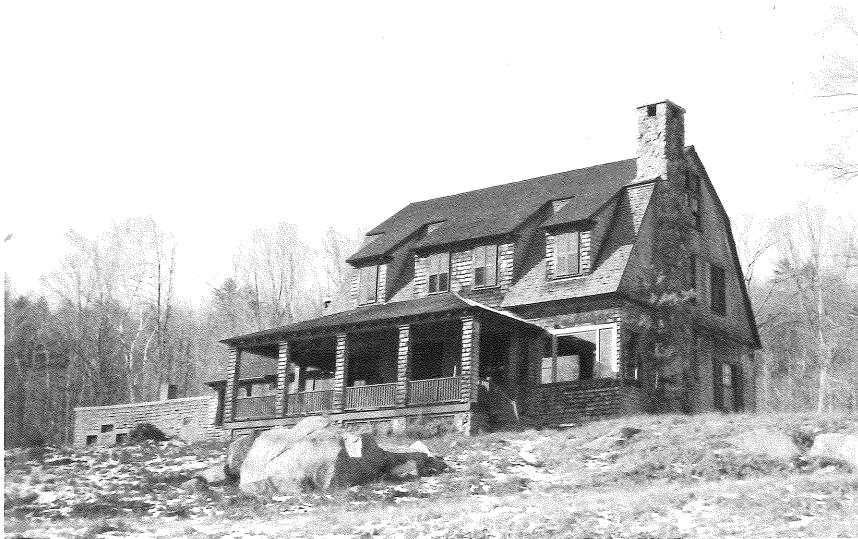
PHOTO:

1. STYLE: Shingle Style BUILDING TYPE: house
2. # STORIES: 1 1/2 DIMENSIONS: 38 x 28 BAYS: 3 x 4 FORM: rectangular plan
3. FOUNDATION: fieldstone 4. STRUCTURE: wooden frame

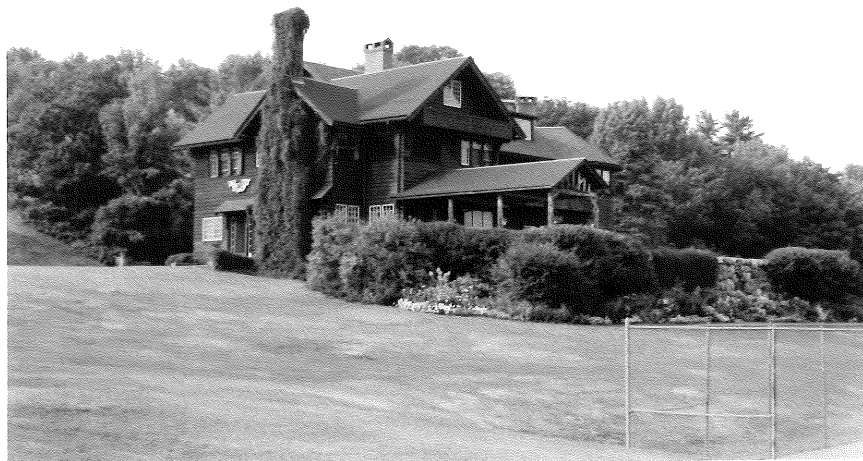
PHOTO:

CONDITION: Exc. ☒ Good ☐ Fair ☐ Poor ☐ Ruins ☐

1. STYLE: Swiss Chalet style BUILDING TYPE: house
2. # STORIES: 2 1/2 DIMENSIONS: 26x64/32x71 BAYS: asymmetrical FORM: asymmetrical plan
3. FOUNDATION: fieldstone 4. STRUCTURE: balloon frame

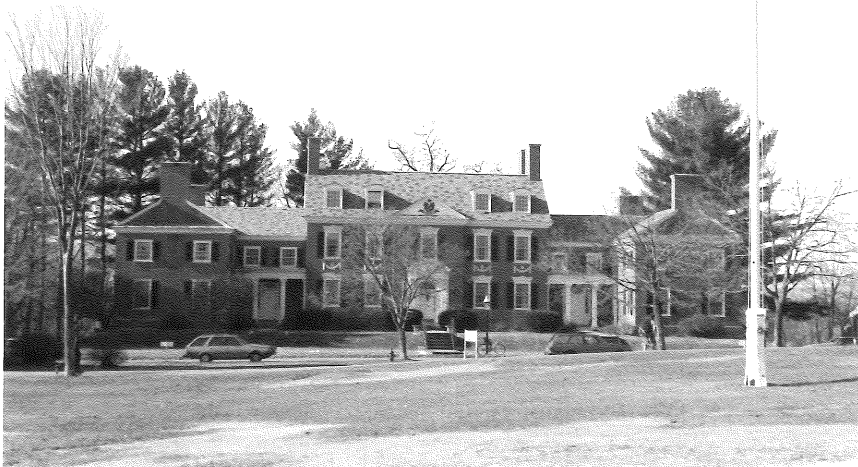
PHOTO:

CONDITION: Exc. ☒ Good ☐ Fair ☐ Poor ☐ Ruins ☐

3. FOUNDATION: concrete, brick 4. STRUCTURE: brick, flemish bond
  5. WALLS: Sheathing brick, flemish bond Ornamentation: watertable, 4 swags on E shield  
in E pavilion

10. ENTRIES-MAIN: Location center, East pavilion Door 6 panel  
Surround: Flanked moulded trim Topped semi-circ. fanlight  
Framed semi-circ. arch, Corinthian pilasters on rusticated piers, segmental pediment  
OTHERS: # 1 Location center, west pavilion Surrounds same as main entry

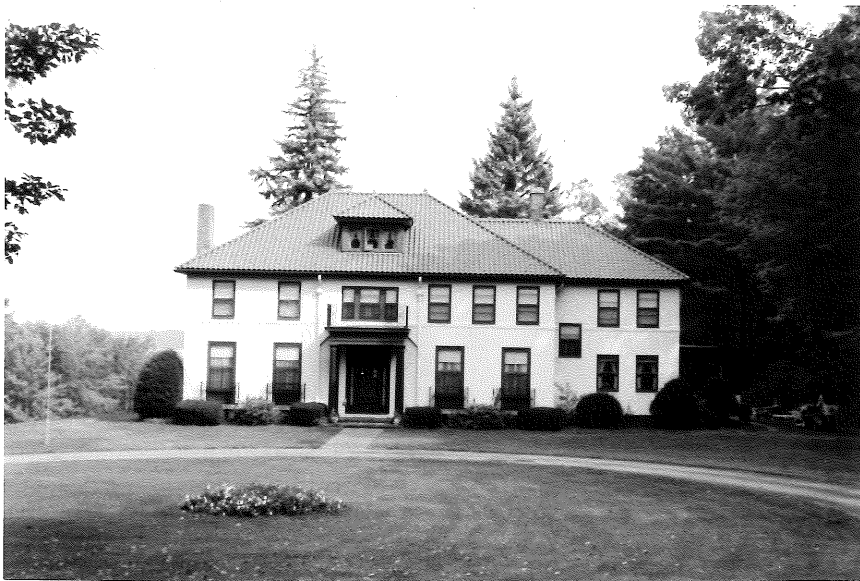
PHOTO:

UTM: \_\_\_\_\_  
USGS QUAD: Holderness  
FUNCTIONAL TYPE: House  
PRESENT USE: House  
ARCHITECT/BUILDER: Mr. Berg of Campton  
CONDITION: Exc. ☒ Good ☐ Fair ☐ Poor ☐ Ruins ☐  
INTEGRITY: Original Site ☒ Moved ☐  
Date \_\_\_\_\_  
Major Alterations & Date:

1. STYLE: 20th century eclectic BUILDING TYPE: house
2. # STORIES: 2 1/2 DIMENSIONS: 34 x 50 BAYS: 5 x 2 FORM: rectangular plan
3. FOUNDATION: concrete 4. STRUCTURE: wooden frame
