Rust Pond

North Inlet and Route 28 Boat Launch Subwatershed Assessment

Prepared for:

Town of Wolfeboro

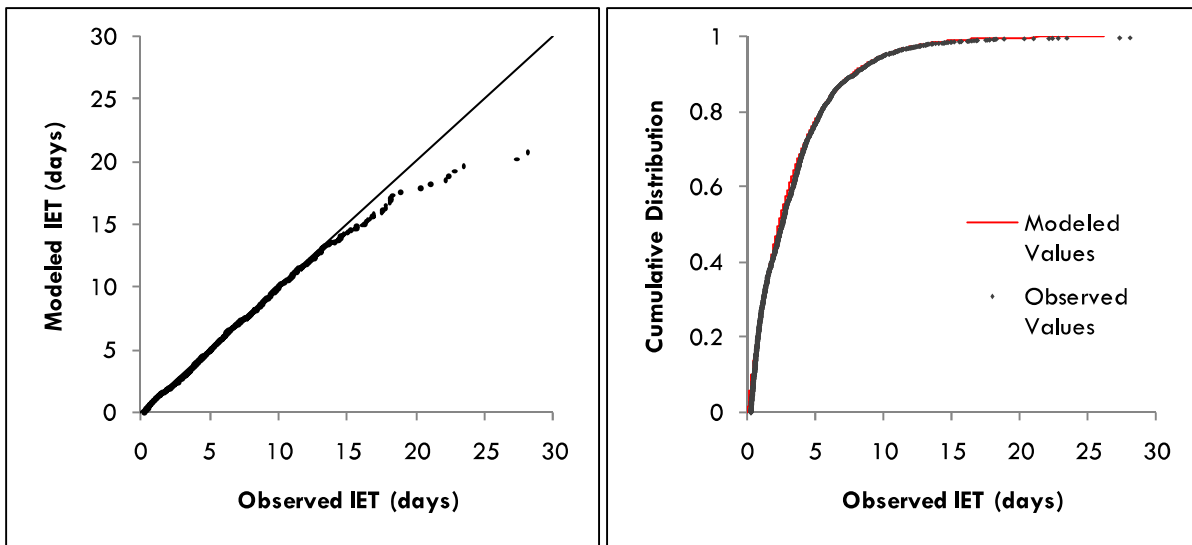
Figures 2.3, 2.4. Observed vs. Modeled IETs, and observed and IET CDF. (Note that the events greater than 18 days were not well described by the model. This represents 0.5% of the observed IETs).

The IET data were fit to an exponential distribution with $\lambda=0.3$. Figures 2.3 and 2.4 show the observed and modeled data plotted on a line with slope 1:1, and the observed and modeled cumulative distribution. The modeled and observed data had a correlation coefficient of 0.96.

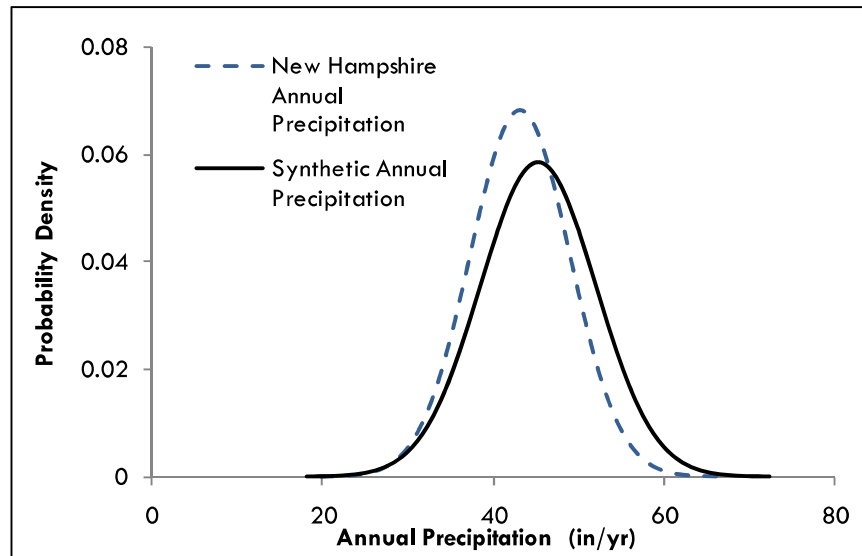
Figure 2.5. Synthetic rainfall data compared to New Hampshire annual precipitation data.

The utility of these distributions was verified by using them to calculate two hundred years of precipitation data. Assuming that the two distributions (event depth and IET) are sufficient to describe a realistic precipitation record, the distribution of actual annual precipitation should be similar to that of the synthetically derived annual precipitation. In Figure 2.5 below, the distribution of modeled annual precipitation totals is compared to the distribution of New Hampshire average precipitation. The mean and standard deviation for Annual Precipitation in New Hampshire is 43.05 and 5.84, respectively, while the mean and standard deviation of the synthetic annual precipitation was 45.23 and 6.80, respectively.

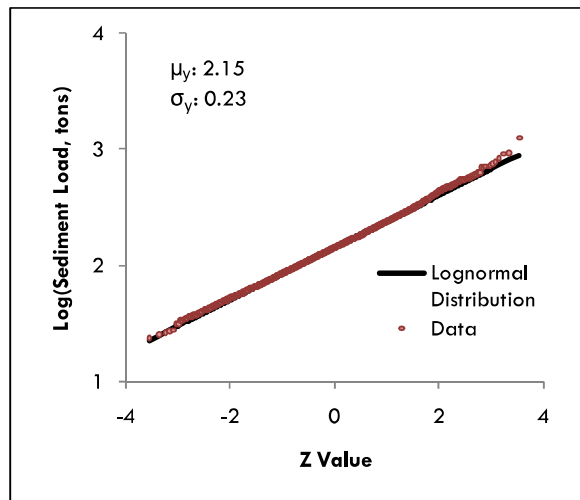
Figure 2.8. Lognormal Distribution of Monte Carlo results for Current Conditions.

The 5000 annual loads calculated in the MC analysis for the current condition followed a lognormal distribution with a mean and standard deviation of the log of TSS load being 2.15 and 0.23, respectively. This translates to an actual predicted average TSS load of 8.63 tons/yr. The MC analysis for current conditions indicates that 50% of the possible annual loading outcomes will fall between 7.41 and 10.05 tons/yr.

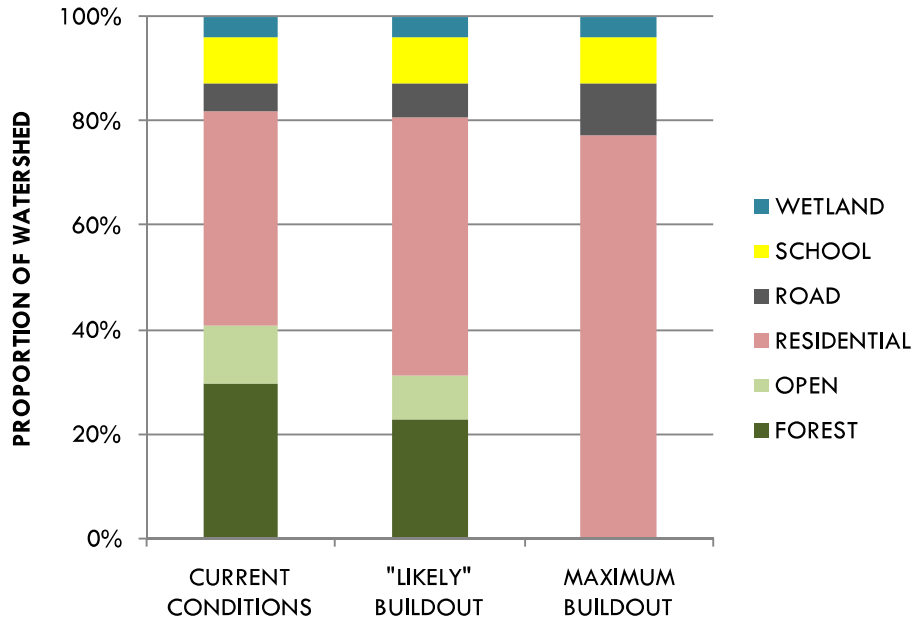
Figure 2.9. Variation in Land Use for buildout scenarios.

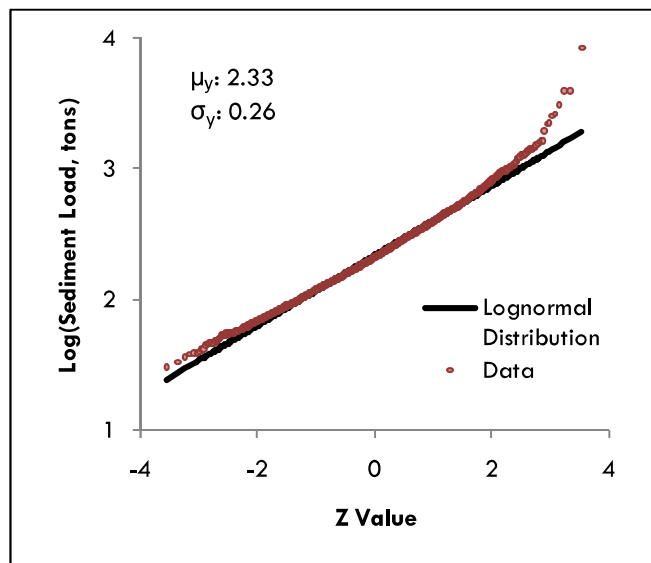
Figure 2.10. Lognormal Distribution of Monte Carlo results for Buildout Conditions.

The 5000 annual loads calculated in the MC analysis for the buildout condition followed a lognormal distribution with a mean and standard deviation of the log of TSS load being 2.33 and 0.26, respectively. This translates to an actual predicted average TSS load under the buildout condition of 10.32 tons/yr. The MC analysis for buildout conditions indicates that 50% of the possible annual loading outcomes will fall between 8.61 and 12.36 tons/yr.

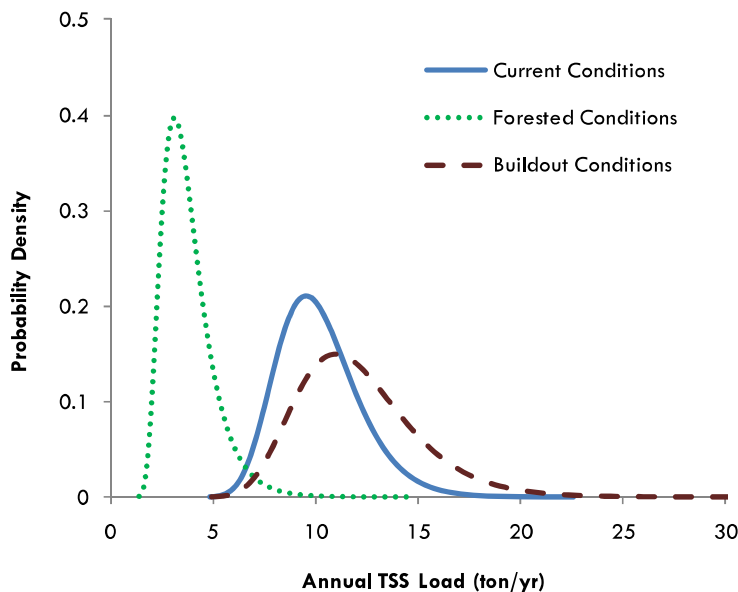
Figure 2.11. Lognormal “bell curve” distributions of model results.

MODEL SCENARIO	MONTE CARLO AVERAGE LOADING (tons/yr)	NORMAL STREAMBANK EROSION (tons/yr)	IMPARED STREAMBANK EROSION (tons/yr)	TOTAL (tons/yr)
Forested	2.64	0.95	0.0	3.6
Current	8.63	0.95	0.43	10.0
Buildout	10.32	0.95	0.43	11.7

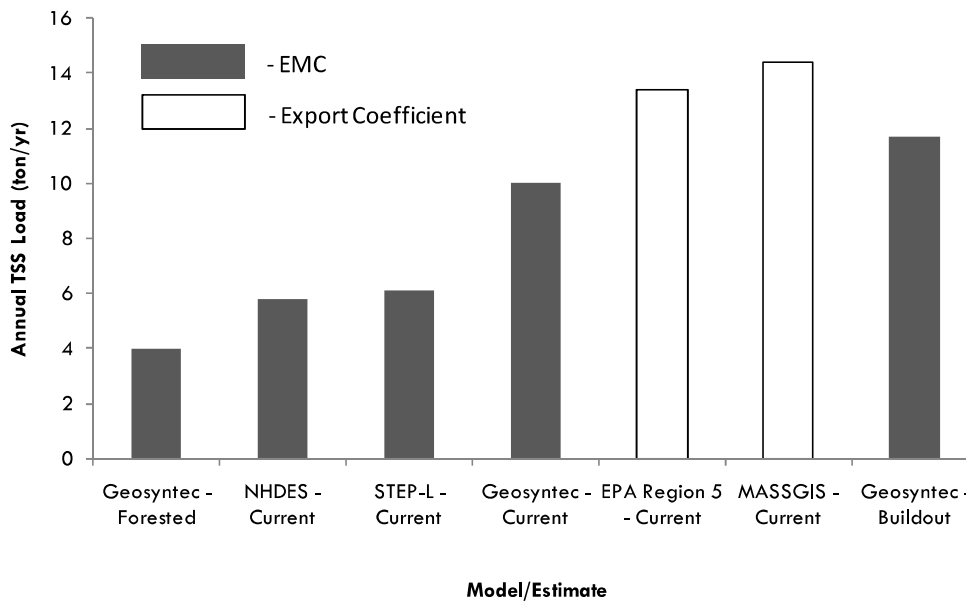
Figure 2.12. Comparison of sediment load estimates.

A comparison of all sediment load estimates is presented in Figure 2.12 below, including the loads presented in Table 2.2, the export coefficient results, watershed sediment load results from the STEP-L model, and an estimate provided by NHDES in the memo entitled “Rust Pond Impairment at the North Inlet.”

As shown in the comparison, Geosyntec’s estimate of current conditions falls between the two methods, STEP-L and export coefficients (EPA Region 5 and MASSGIS). Additionally, the distribution resulting from the Monte Carlo analysis includes the other estimates within its range. These two facts lend credibility to the estimate of 10.0 tons/yr.
